# SERVICE BULLETIN

SB No. 44 Issue No. 1

**TITLE**
**CHECK ON CLEARANCE BETWEEN FORWARD U/C LEG AND ENGINE MOUNTING FRAME**
**CLASSIFICATION**

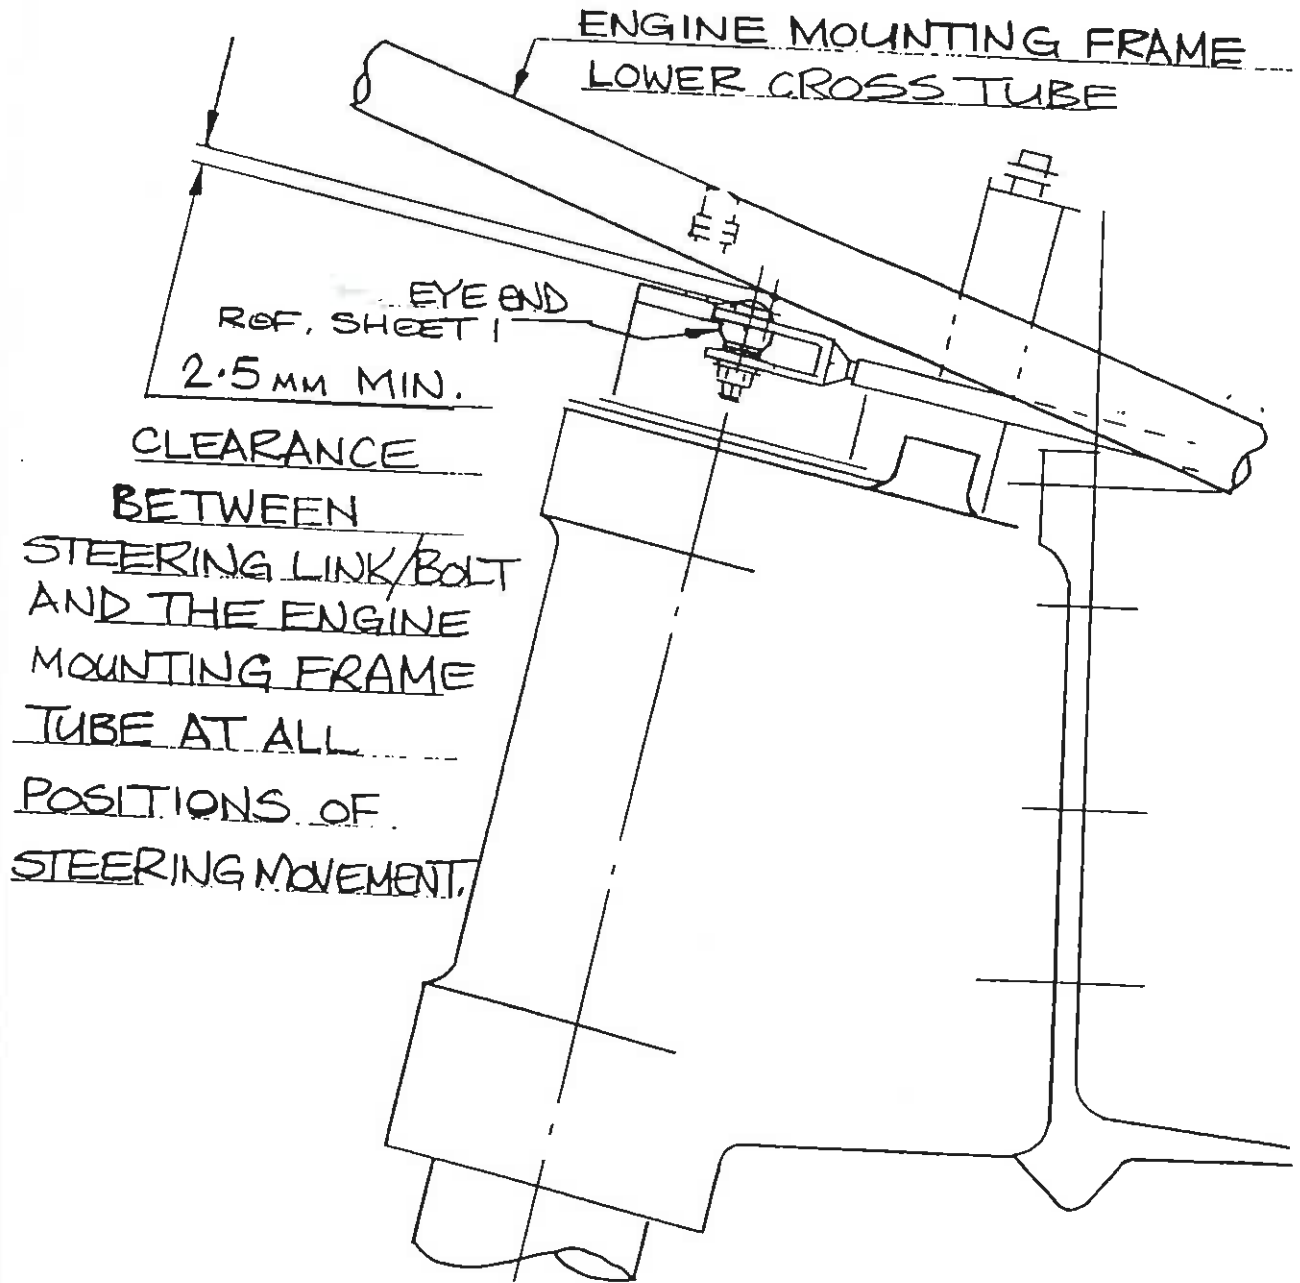
It has been reported on certain aircraft fitted with Falrey Hydraulics undercarriage system that part of the nosewheel steering mechanism can foul on the underside of the engine mounting frame. This inspection is introduced to check that there is adequate clearance between the two items. Further modification action will be necessary if the required clearance is not achieved.

1. Ensure ignition and battery master switch is in the off position.
2. Position grease plates under the nosewheel of the aircraft. The aircraft must be standing freely on its undercarriage with parking brake on. Remove top and bottom engine cowlings.
3. Referring to the attached Figure 1, check the clearance between the nosewheel steering pushrod connecting bolt and the lower engine cross tube. The clearance should be 2.5mm or greater. Turn the nosewheel and check the clearance in all positions.
4. Check the underside of the engine mounting frame in the vicinity of the pushrod for signs of paint removal, scratches and corrosion.
5. If adequate clearance exists and there is no sign of damage to the mounting frame annotate the aircraft log book "SB accomplished".

If there is insufficient clearance but the engine mounting is not damaged, fit a modified steering pin in accordance with Modification No. M575 within the next 50 flying hours.

If the engine mounting tube has been damaged by the pin the aircraft must not be flown until the damage has been rectified and Mod M575 incorporated.
