# Service Bulletin

S.B. No: **82**

**Title: INSPECTION OF WING WALKWAY AREAS**

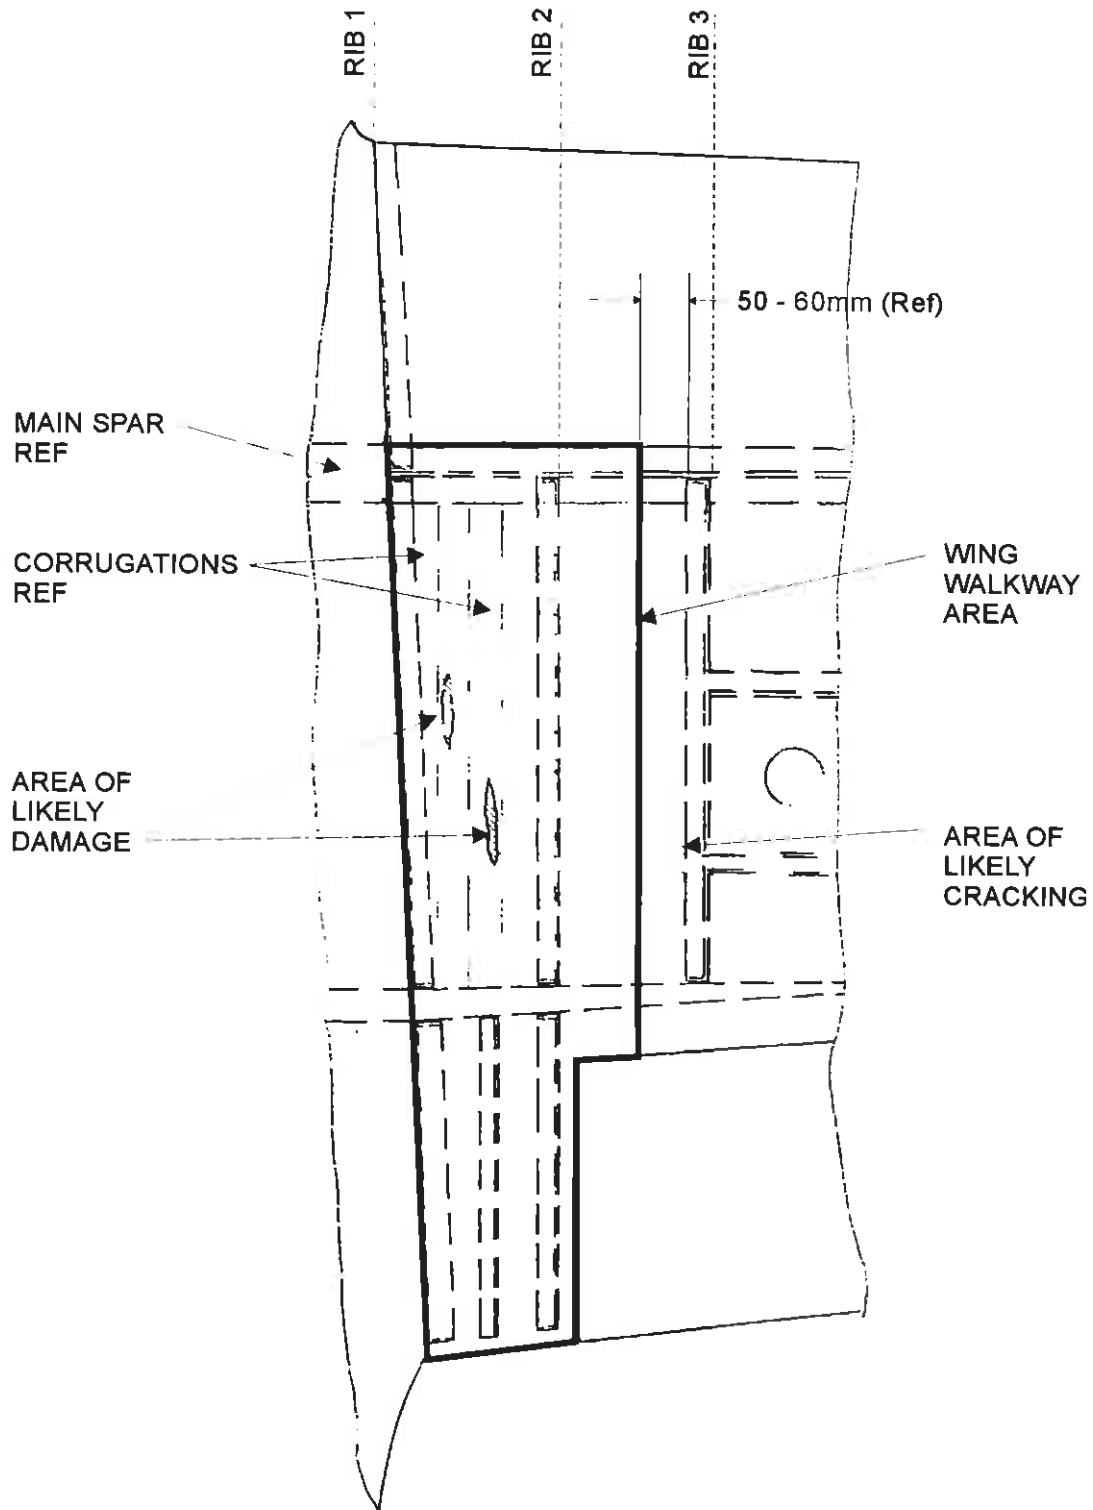
FIGURE 1 STBD (RH) DRN - PORT (LH) SIMILAR

Two cases have been reported of delamination in the skin and corrugations in the area of the wing walkway. Reference Figure 1.

Subsequent to Issue 2, cracking inboard of Rib 3 flanges has been reported.

1. At next 150 (or 100 for US registered aircraft) flying hour check, reference Figure 1:
  - i. Visually inspect wing walkway area by either viewing through flap drive access hole in undersurface of wing or through Rib 1 (seats out). Also press down over wing walkway area: there should be no signs of delamination on corrugation or "spongy" feel to walkway.
  - ii. Inspect for cracking in region of Rib 3, by pressing down slightly inboard of the rib and noting any relative movement of skin.
2. If the wing is not damaged, refer to Action Matrix Reference # 1.

3. If the wing walkway area is found to be suspect or has damage, remove wing walk tape and surface finish to ascertain degree of damage. Wing walkway tape is to be carefully removed by removing wing seal, lifting corner of wing walk tape and pulling back applying gentle heat at the base of the lifted tape. Ensure the heat source is not stationary at any one point.

4. If there is damage to the wing walk way skin or corrugation refer to Action Matrix References # 2 – 5 and 8 for action to be taken.
5. If there is damage/cracks at Rib 3 then refer to Action Matrix References 6 – 8 for action to be taken.  
If in doubt, contact SACL Customer Support Department.
