Service Bulletin

S.B. No: 161

Title: FUEL TANK VENT PIPE CHECK

Applicability: T67C Post Mod M156, T67M-MkII, T67M200, T67M260 and T67M260-T3A

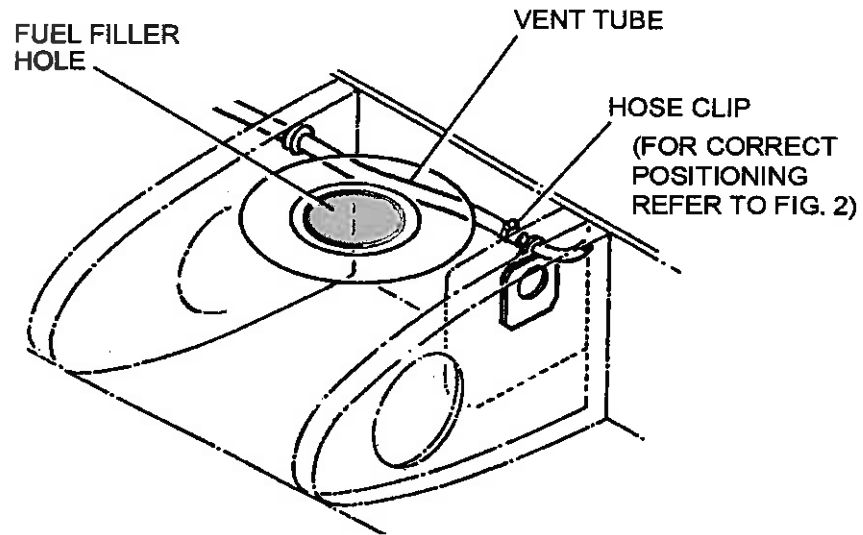
Figure1 Wing Tank Fuel Vent Pipe

A case has been reported of the vent tube in the tank becoming detached from its fitting. The problem may have occurred during refuelling. A non-standard refuelling nozzle placed into the filler hole may catch the vent tube.

1. Remove fuel filler caps from both wing tanks, ensure safety precautions are observed.
2. Using a mirror and a torch (if required) observe fuel vent tube, ref Figure 1.
3. Check:
 - i) Correct routing of vent tube, ie straightness. If tube is slack ensure it cannot be fouled by refuelling nozzle.
 - ii) Vent tube hose clip is still in its correct position, tight and is correctly supporting the vent tube. Ref Figure 2a (Pre Mod M554) or Figure 2b (Post Mod M554).
4.
 - i) Should inspection prove satisfactory annotate logbook "SB161 complied with."
 - ii) If requirements of paragraphs 3 i) and ii) cannot be satisfied then gain access to wing tank as per Maintenance Manual and rectify. Upon rectification annotate logbook "SB161 complied with."
