# SERVICE BULLETIN

SB No. 35 Issue No. 2

**TITLE**
**WING REAR SPAR INSPECTION T67A AIRCRAFT**
**CLASSIFICATION**

All T67A aircraft (wood aircraft).

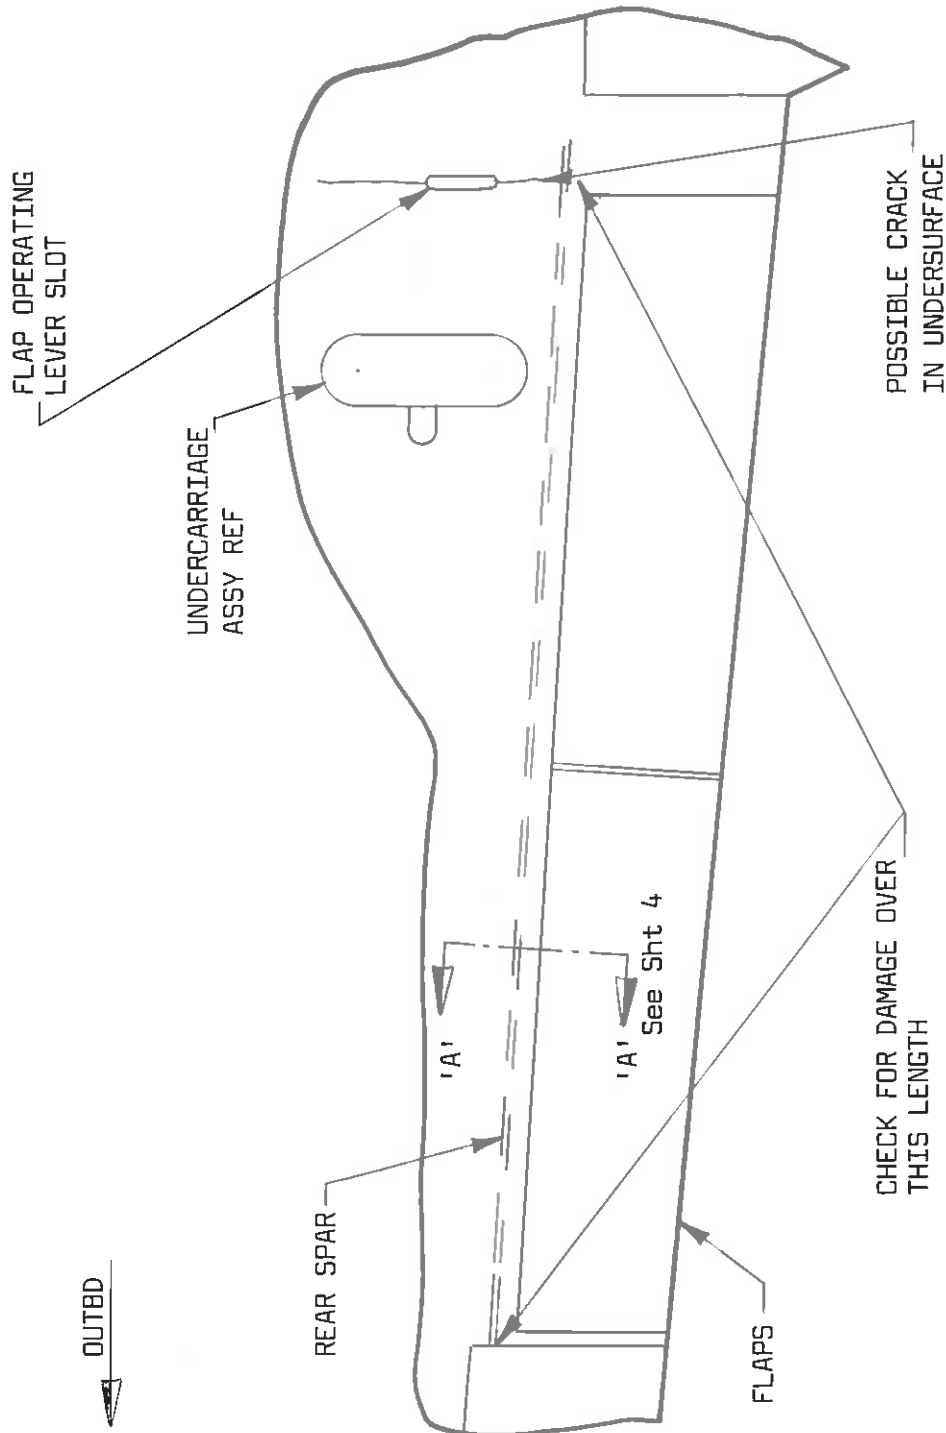
FIG 1  
VIEW ON UNDERSIDE OF STBD WING  
PORT SIMILAR

During a repair to the starboard lower skin of a T67A, it was found that the rear spar booms in an area to the rear of the undercarriage were spongy. Further investigation revealed that the lower boom was affected outboard for approximately 2 metres. The type of damage is consistent with water ingress.

1. Remove port and starboard flaps.
2.
  - i) Clean and inspect all of rear spar and supporting structure in area of flaps for cracks in paint finish and defective structure. Ref. Fig. 1.
  - ii) If spar is covered in fabric, this fabric is to be carefully removed, to extent shown on Fig. 2, for inspection.
3.
  - i) If damage is found, inform SAL Product Support Department before further action.
  - ii) If in doubt, carefully remove paint and fabric as required.
    - a) If structure shows signs of damage or water ingress, inform SAL Product Support Department.
    - b) If no sign of damage or water ingress, replace fabric as required and restore finish.
  - iii) If no damage found, ensure fabric and paint finish is in good order. If not restore fabric and finish.

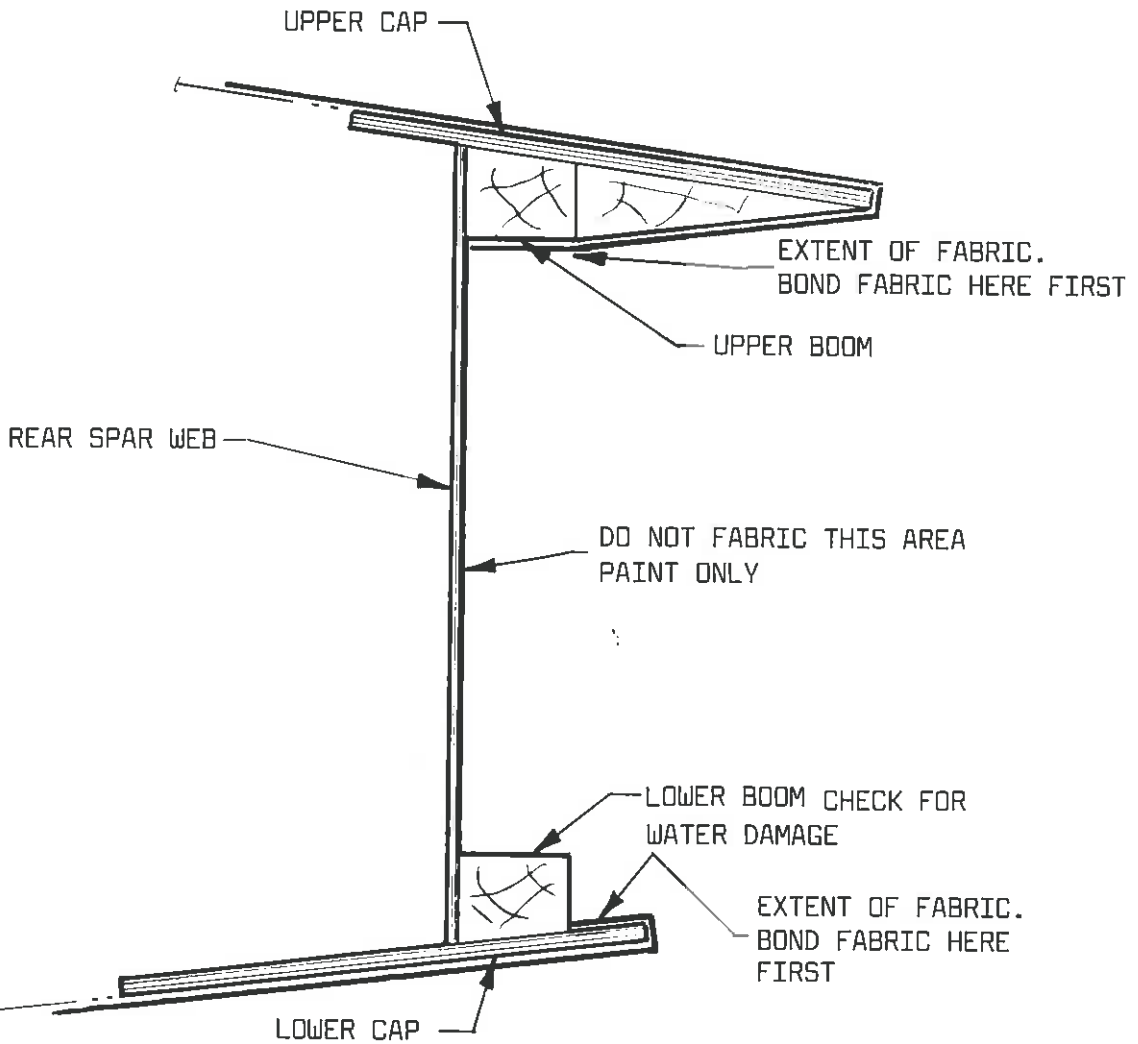
SECTION A-A  
(ROTATED THRU' 90°)  
SHOWING SECTION THROUGH REAR SPAR

Additionally it was noticed that the fabric of the wing continued down the face of the rear spar. This prevents the rear spar from being fully visible for inspection and provides water traps.

9. Ensure when applying that the fabric starts at t/edge as shown on Fig. 2. It is recommended during re-fabricing, this area is bonded first and cured, then fabric is pulled forward and bonded.
