MARSHALL AEROSPACE AND DEFENCE GROUP SERVICE BULLETIN SBM 198

MARSHALL AEROSPACE AND DEFENCE GROUP INSPECTION OF POST MOD M501 T67M260 FIREFLY
RUDDER PEDAL CABLES FOR FOULING AND AIR CONDITIONING HOSES FOR DAMAGE

Dated September 2013

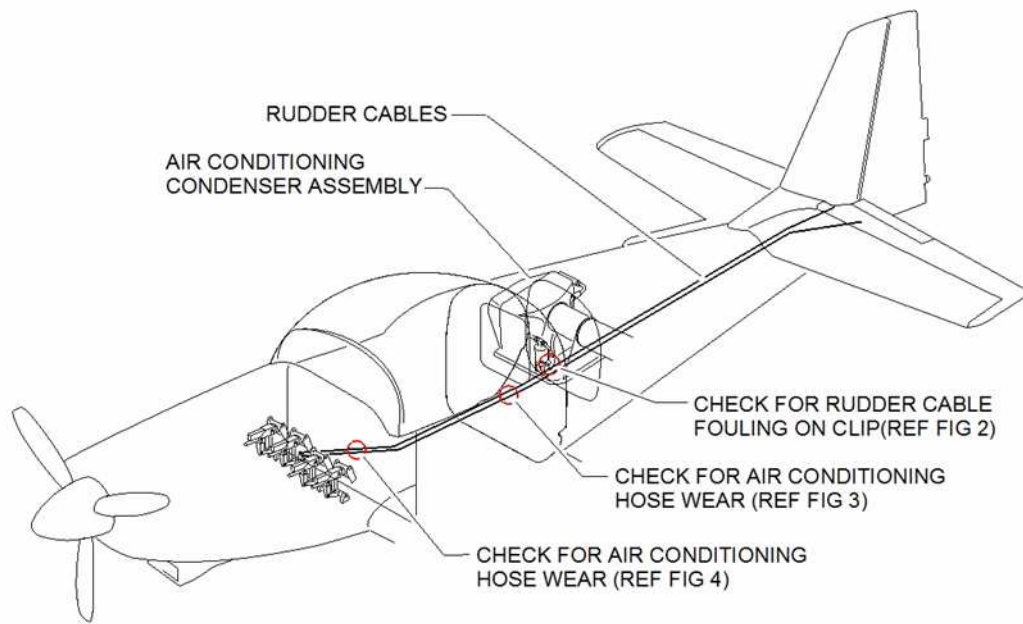
Figure 1 Areas of inspection

- (1) Inspect the areas of potential rudder cable fouling and air conditioning hose wear, refer to Figure 1.
- (2) If the air conditioner drier clip is positioned as shown in Figure 2 there is a risk of the Starboard rudder cable fouling on the top of the clip fastener. If the clip is in the position shown (inset detail Figure 2) the clip must be repositioned (turned through 90°) so that there is no possibility of the rudder cable fouling on the clip fastener.
- (3) Check condition of the hoses (refer to Figure 3 and Figure 4) if any wear is found on the hose it must be repaired or replaced.

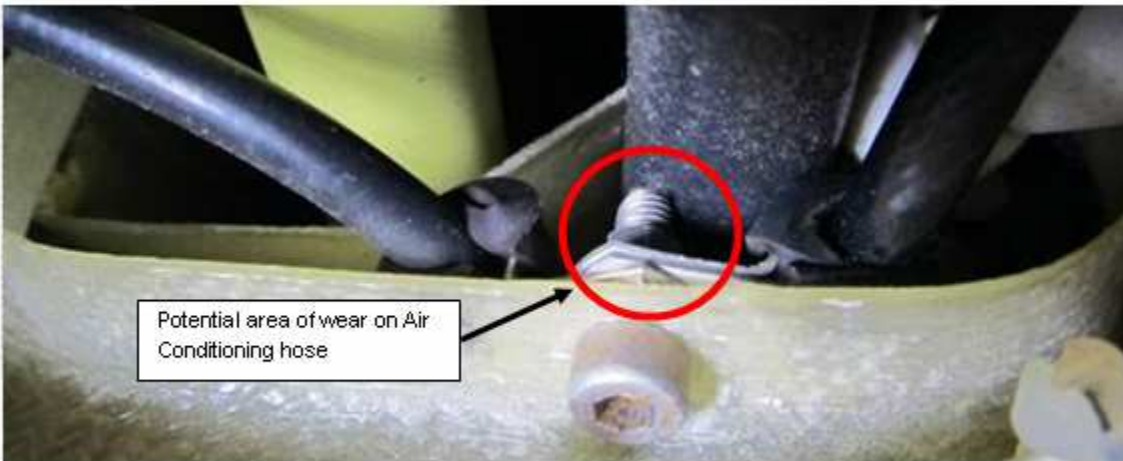
Figure 3 View looking down and forward from behind Frame 5

- (1) Any hose that does not have sufficient clearance (6mm – 12mm) in the positions shown in Figs 3 and 4 must be repositioned to ensure it is clear of structure or moving parts which could cause wear to the hose. Any hose/component that is repositioned must be held in place with approved aerospace parts as required. If in doubt seek guidance advice from Marshall Aerospace and Defence Group Advanced Composites Product Support Department.

(2) Should it be necessary to replace any hoses refer to the Keith Products System Service Manual TR-134 for removal and installation procedures and subsequent leakage checks.
