SERVICE BULLETIN

71

INSPECTION OF RUDDER PEDAL LAYSHAFT MOUNTING BRACKETS

T67M260-T3A and T67M260 Pre Mod M720 Aircraft.

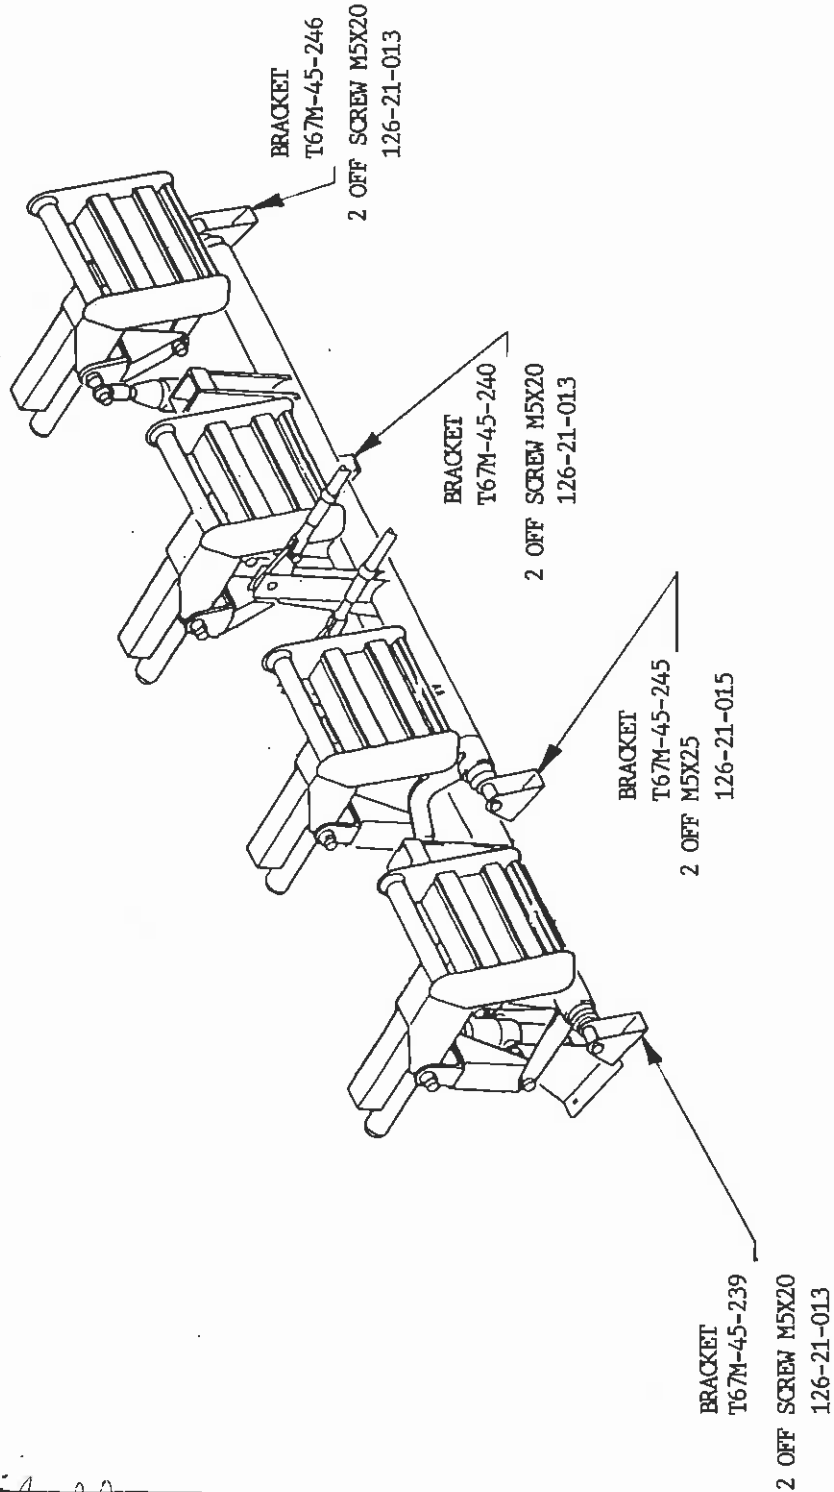
Fig 1
RUDDER PEDAL MECHANISM

It has been reported that on a few aircraft the rudder pedal bar support bracket screws are loose requiring one to two turns to tighten.

1. Gain access to brackets ref. Fig. 1.
2. Check mounting fasteners for security (2 off per bracket), screw in any loose fasteners.
3. Tighten all fasteners to torque value of 58 lbf in (6.5 Nm).
4. Reassemble aircraft ref Action 1.
5. Annotate in Log Book SB 71 Issue 2 carried out.
6. Actions 2 to 5 to be repeated every 150 hr intervals until Mod M720 incorporated.
