Service Bulletin

S.B. No: 133

Title: INSPECTION OF FLAP LEVER PIVOT ATTACHING POINT FOR CRACKING

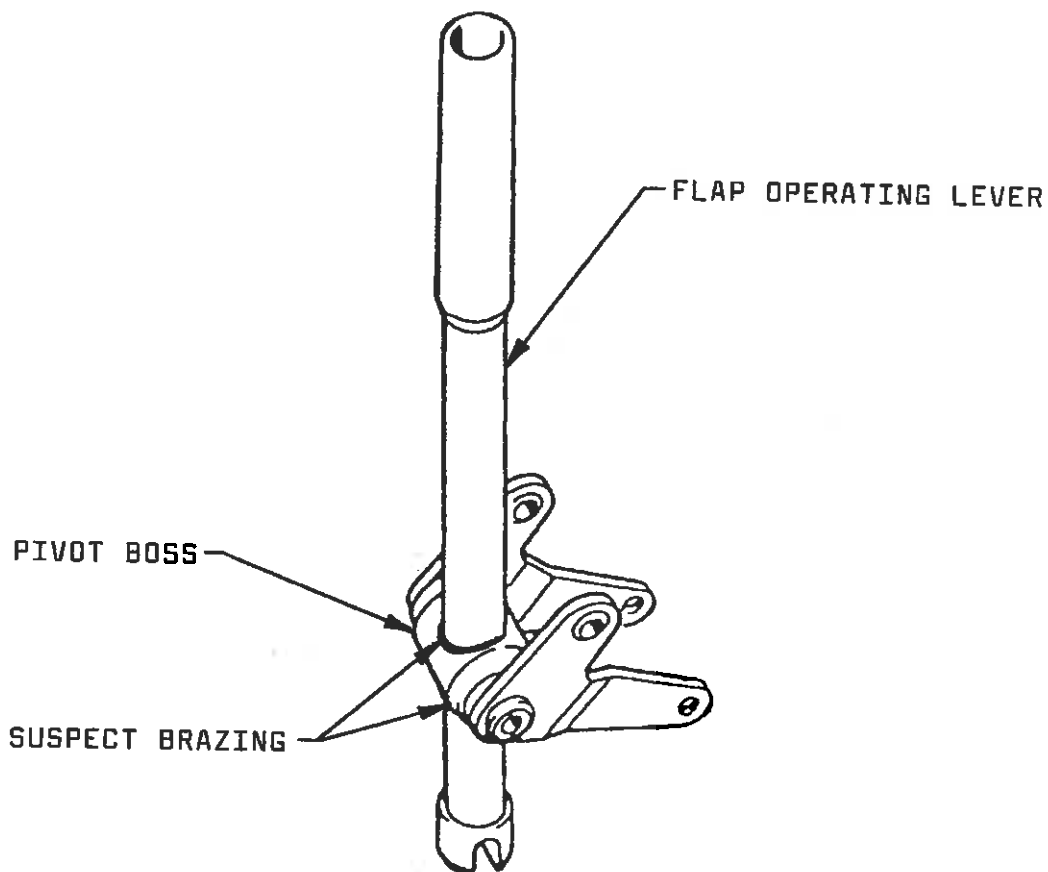
FIGURE 1 FLAP OPERATING HANDLE
(ITEMS DELETED FOR CLARITY)

Cases have been reported of cracking in the brazed joints above and below the Flap Operating Lever pivot point. This SB requires an inspection to be carried out on the Flap Lever, pivot boss.

3. Inspect, using a strong light and mirror, all brazing between lever and pivot boss, above and below pivot, refer Figure 1.
 - i. If no cracking is present in the brazed joint, then certify item as serviceable. Annotate aircraft Logbook "Service Bulletin 133 complied with". Re-inspect at next Annual until welded lever Part number T67B-45-262 at issue 2 and subsequent incorporated.

- ii. If brazed joint is found to be cracked, remove flap lever assembly, strip down flap lever completely and replace lever with welded lever Part number T67B-45-262 at issue 2 and subsequent, and annotate Logbook "SB 133 complied with".
