SERVICE BULLETIN

74

TITLE
INSPECTION OF ROUTING OF UPPER SPARK PLUG LEADS
CLASSIFICATION

APPLICABILITY: T67M260 & T67M260-T3A.

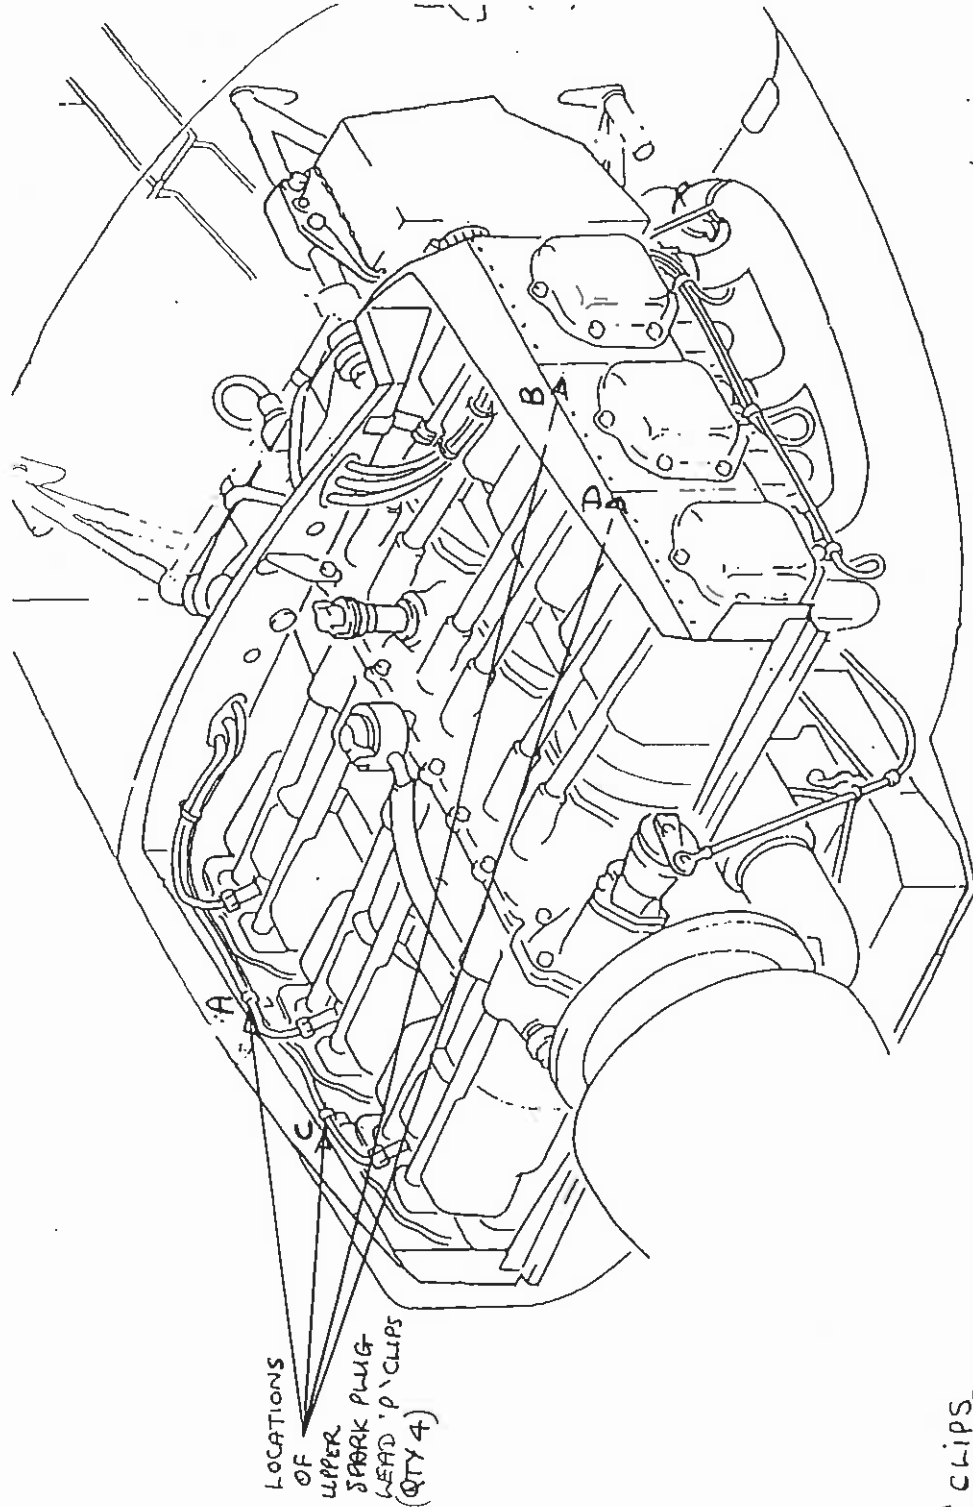
There has been a report of the upper spark plug leads chaffing on the rivets that secure the rubber baffle material to the aluminium baffles. The standard 'P' clips supplied by Lycoming in the engine kit, hold the plug leads too close to the rivets.

LOCATION (See DIAG)	EXISTING PART NO	NEW PART NO (MOD GSB)	Nº OF PLUG LEADS SECURED
A and B	MS21919 JGG6	T67G-50-683	2
C and D	MS21919 PG4	T67G-50-681	1

3. Locate 'P' clips which secure spark plug leads to baffle (2 each side of engine). Bend 'P' clips inwards towards engine to an angle of 45° to the vertical to increase clearances between plug leads and engine baffles. It is not necessary to remove 'P' clips.

4. Where two leads run together between 'P' clips, tyrap them securely together in a position away from the baffles.
5. Where 'P' clips require replacement use T67G-50-681 to secure a single plug lead and T67G-50-683 to secure two plug leads. These are specially pre-angled.
