Service Bulletin

S.B. No: 188

Title: INSPECTION FOR RUDDER PEDAL CLEARANCES BETWEEN RUDDER PEDALS AND THE AIRCRAFT STRUCTURE AND COMPONENTS

Applicability: T67B, T67C series, T67M, T67M-MkII and T67M200 (excluding works no. 2264 & 2265).

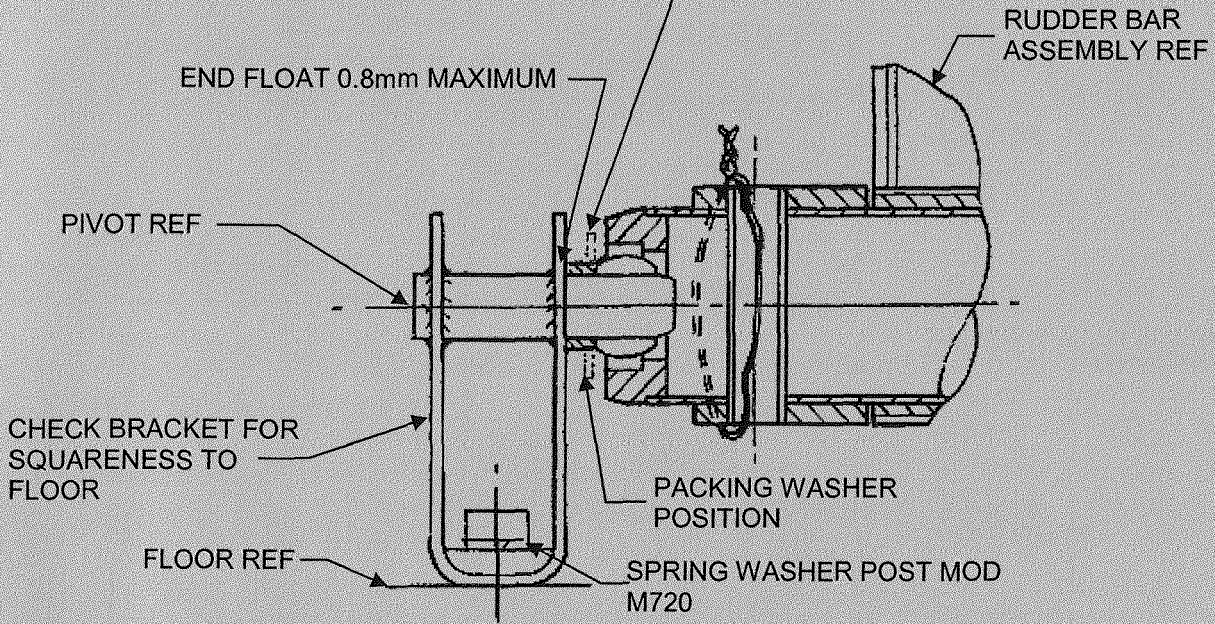
FIGURE 1

3. Check rudder pedal bar end float is no greater than 0.8mm. If it is greater than 0.8mm then rectify end float IAW paragraph 8. Refer Figure 1.
4. Check that the Rudder Pedal bar port outboard support bracket, ref. Figure 3, is square to the floor and not "lozenged" and there is no deformation to its base. Check floor panel under area of bracket, inspect for cracking which could allow the bracket to lean. If necessary remove floor panel and check for signs of cracking in the floor around the anchor nuts on Pre Mod M919 aircraft or the anchor nut mounting plate Post Mod M919 aircraft, refer Figure 2. Any GRP damage will be shown as a white shadow on the GRP, with cracking felt as a rough edge. A light shining up through the floor will show a shadow.

SPACER T67M-45-507 OR 1 OFF WASHER 126-23-748 PLUS 1 OR 2 OFF 126-23-749 WASHERS MUST BE FITTED

RUDDER BAR END FLOAT AND ITS SUPPORT BRACKET

6. Should Rudder bar support bracket be damaged replace with new item. Ensure bracket is secured with a torque of 58lbf in (6.5Nm). Spring washers may be fitted; Mod M720 "Introduction of Spring Washers to Rudder Pedal Lay-shaft Mounting Bracket Screws" refers. See Figure 1.

8. Referring to Figure 1 ensure at each rudder bar pivot position that there is one spacer T67M-45-507 OR one off washer 126-23-748 and up to a maximum of two off washers 126-23-749, i.e. 3 washers maximum.

If end float greater than 0.8mm, then 1 off packing washer may be added at each pivot position as required, i.e. 126-23-105 washer or 126-23-748 washer or 126-23-749 washer.

If packing washers are required on the right hand rudder bar (T67M-45-259), then the packing washer, (or the thicker washer if a thick and thin washer are required) should be placed at the outboard pivot. When end float of 0.8mm maximum achieved ensure that the brake cylinders are not subject to undue side load. If in doubt contact SACL

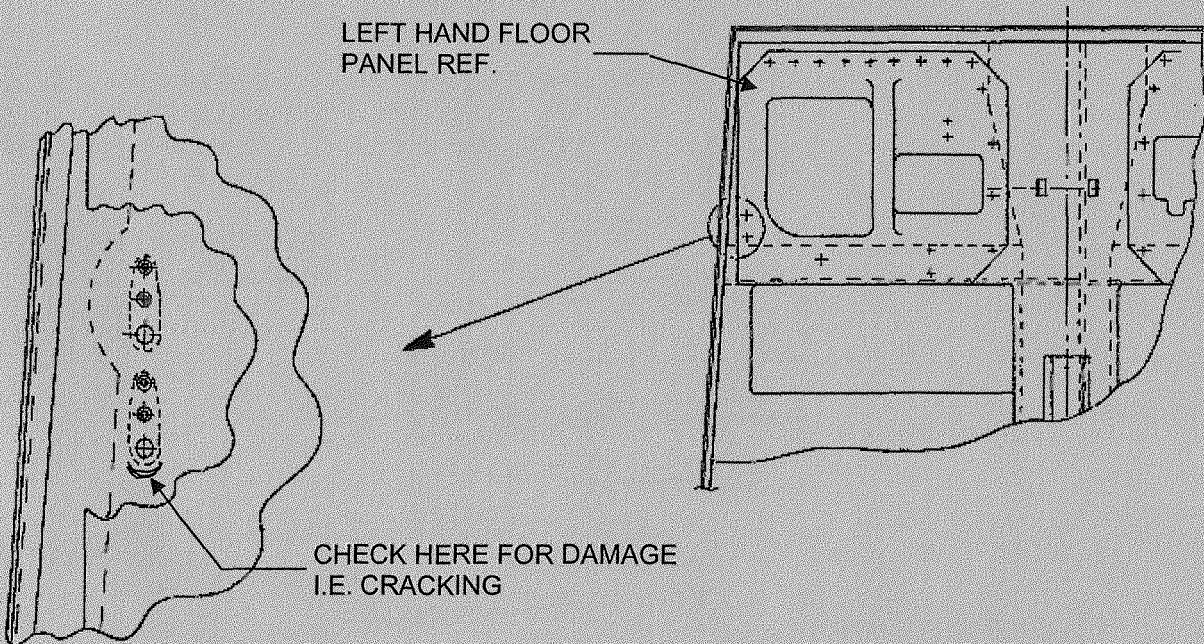
FIGURE 2

AREA OF FLOOR REQUIRING INSPECTION (PRE MOD M919 DRAWN)

5. If floor is found to be cracked or broken then repair IAW DOI T67C-149 incorporating Mod M919. If Mod M919 has been previously incorporated and floor is damaged inform SACL.

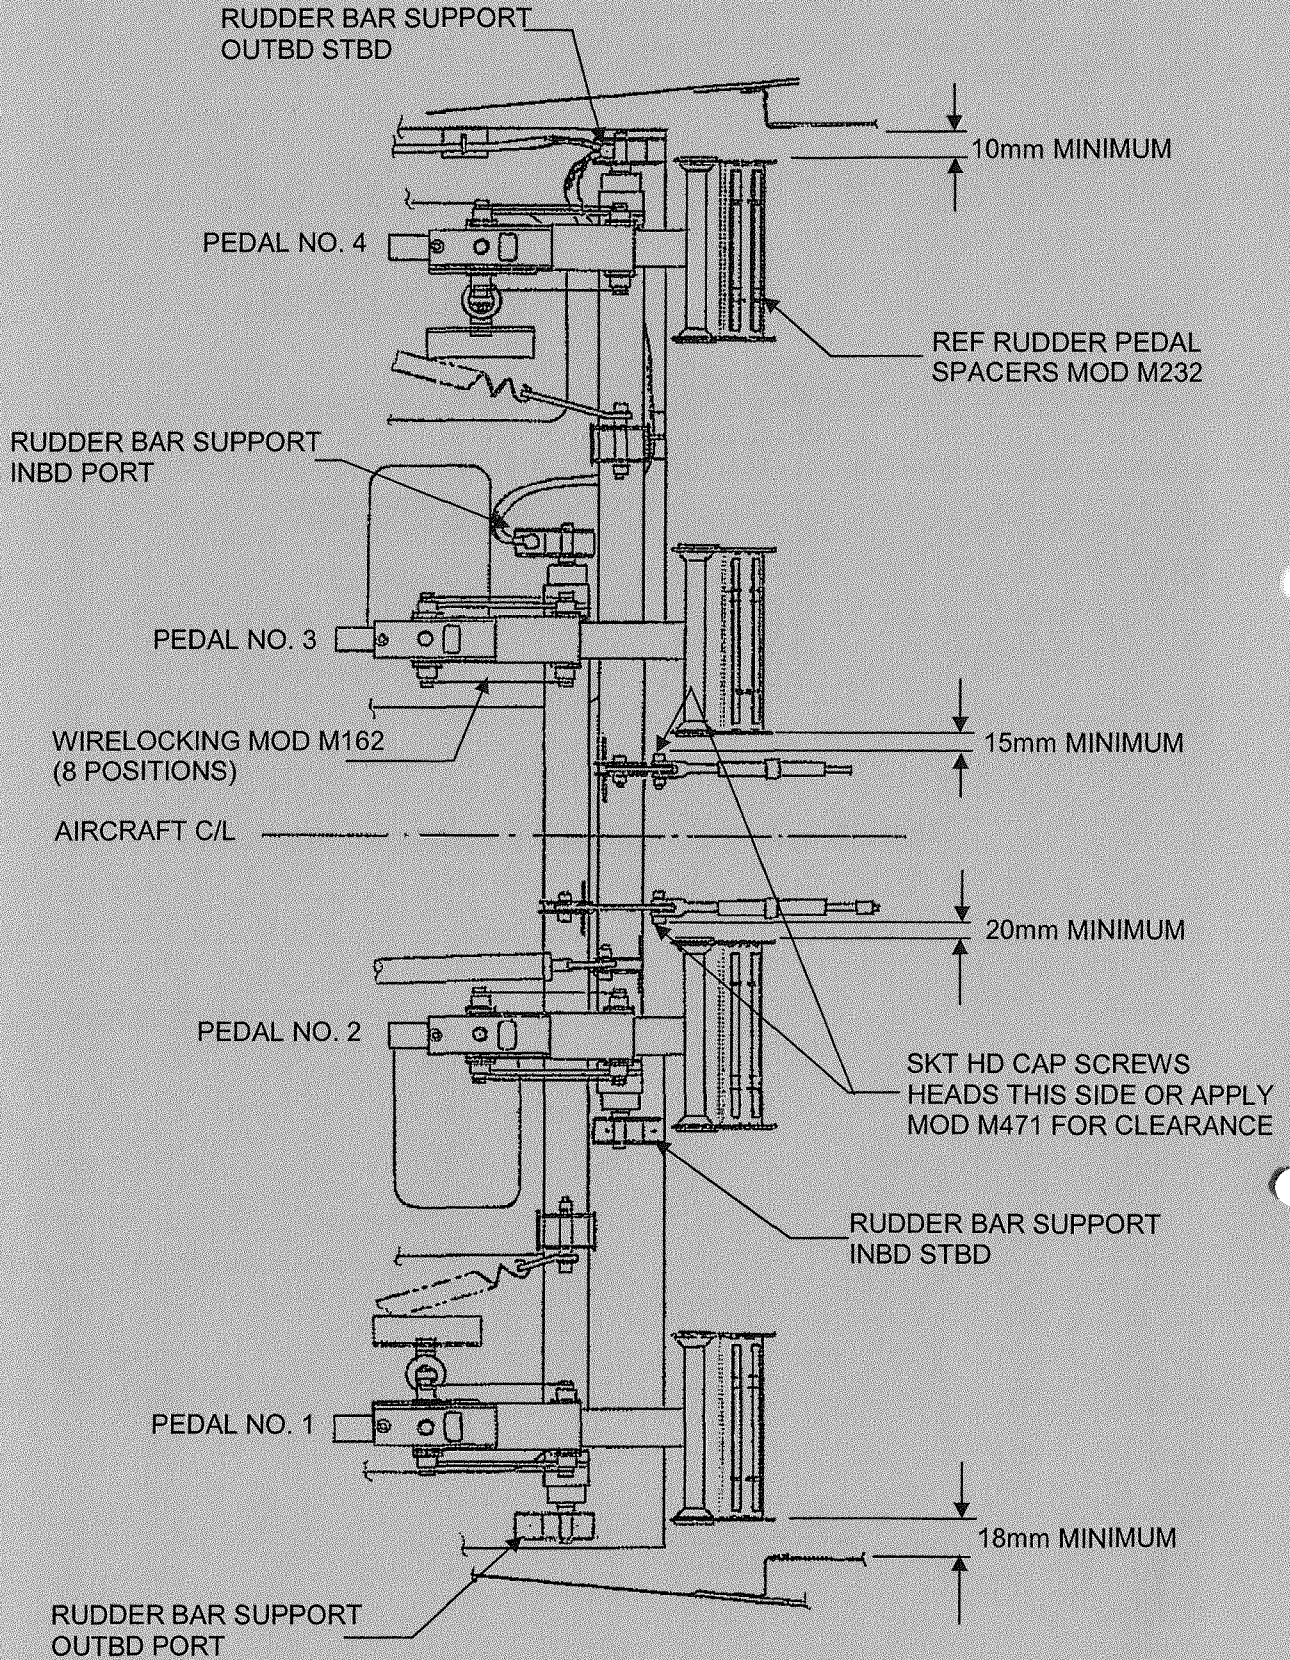
FIGURE 3

7. Check the remaining rudder bar support brackets, ref. Figure 3, are square to floor and not "lozenged" and there is no deformation to their bases. If any bracket is found to be suspect replace with new item. Inform SACL of any damaged bracket. Assemble item as per paragraph 6 and ensure end float is as stated in paragraph 8. Ensure bonding leads are correctly fitted, carry out bonding check refer relevant aircraft's Maintenance Manual.

14. Ensure head orientation of rudder cable link bolt head is outboard, Figure 3 refers, this is a Low Pan Head bolt T67M-45-570 on Post Mod M471 "Introduction of Pan Headed Bolt on Rudder Cable Turnbuckles", aircraft.

RUDDER PEDAL CLEARANCES TO SIDE PANEL AND RUDDER CABLES

16. Ensure the requirements of, SB 99 "Inspection and Rectification of Rudder Pedal Sliders", has been achieved.
17. Ensure rudder pedal carriage socket head caps screws are wire locked and bonded in with adhesive 126-51-024, use minimum amount, Mod M162 "Wire Locking of Rudder Pedals – Upper Pivots", refers. See Figure 3.

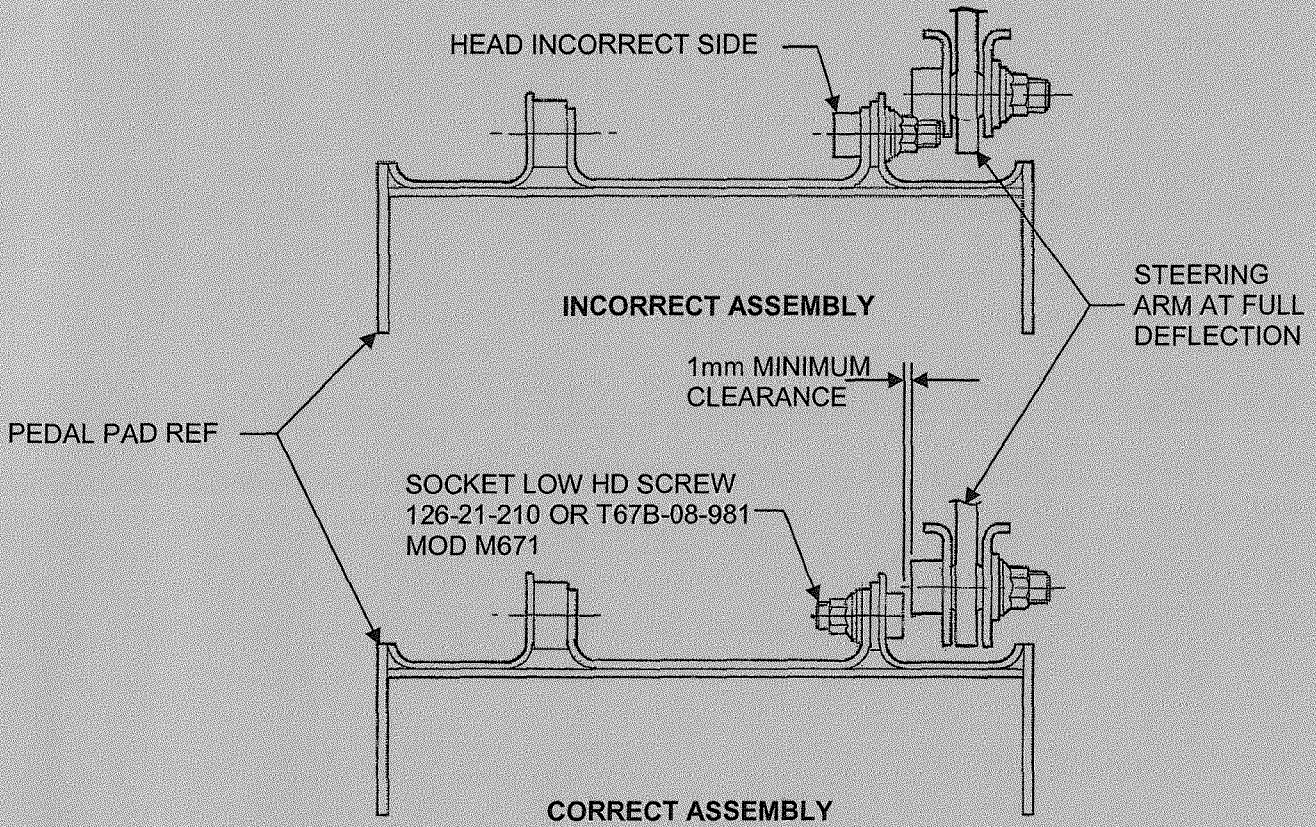
FIGURE 4

15. Ensure Pedal no 2 Pedal pad pivot bolt head height is less than 5mm and orientated as shown in Figure 4. A minimum of 1mm clearance is required, if not fit part no 126-21-210 or T67B-08-981, this invokes Mod M671 "Introduction of Low Head Rudder Pedal Pad Pivot Bolts – Pedal No. 2".

PEDAL NO. 2 TO STEERING ARM INTERFACE

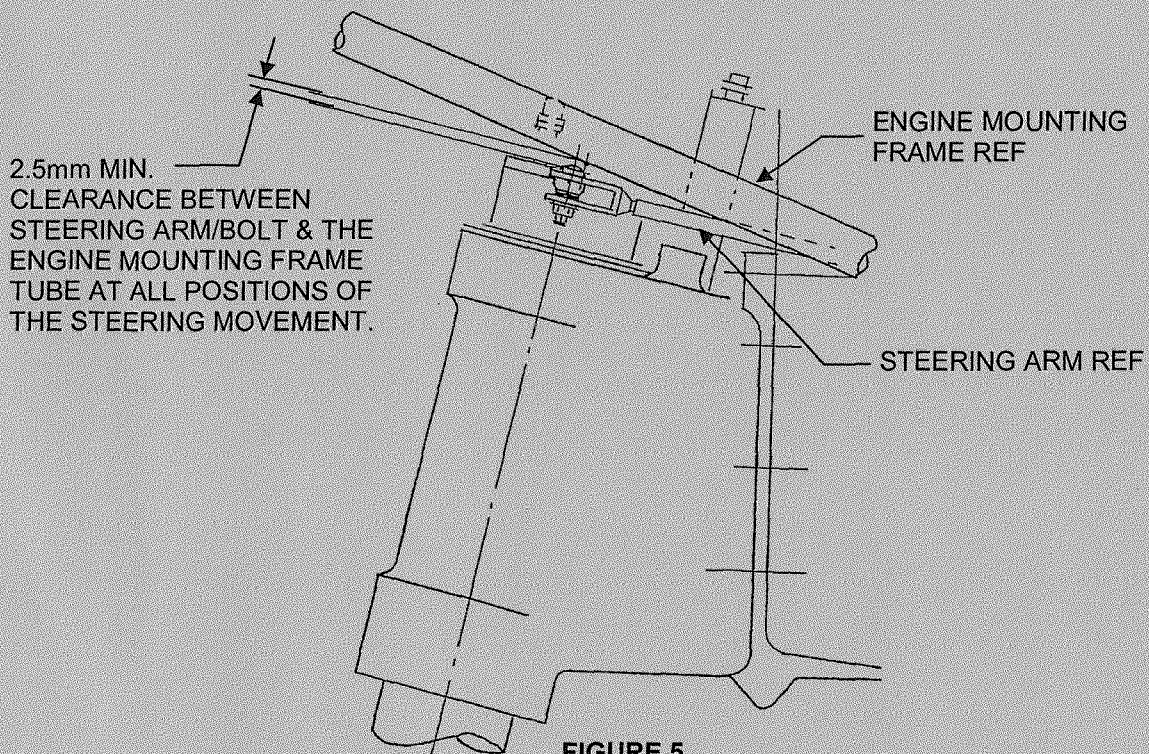
FIGURE 5

18. Ensure on aircraft fitted with the Fairey Hydraulic undercarriage, (Post Mod M468 or Mod M791), that there is a minimum clearance of 2.5mm with steering linkage to engine mounting frame, see Figure 5. Ensure there is no damage to engine mounting frame if clearance is less than 2.5mm. If engine mounting frame is damaged then aircraft must not be flown until damage is rectified, consult SACL. Also if clearance is less than 2.5mm embody Mod M575 "Introduction of Offset Steering Arm Pin – Ref Fairey Hydraulics Nose U/C", if Mod M575 is fitted and clearance is less than 2.5mm inform SACL.

STEERING ARM ENGINE MOUNTING FRAME CLEARANCE
