**SERVICE BULLETIN**

SB No. 115 Issue No. 1

INSPECTION OF LEFT HAND PILOTS THROTTLE PUSHROD

T67M260 and T67M260-T3A.

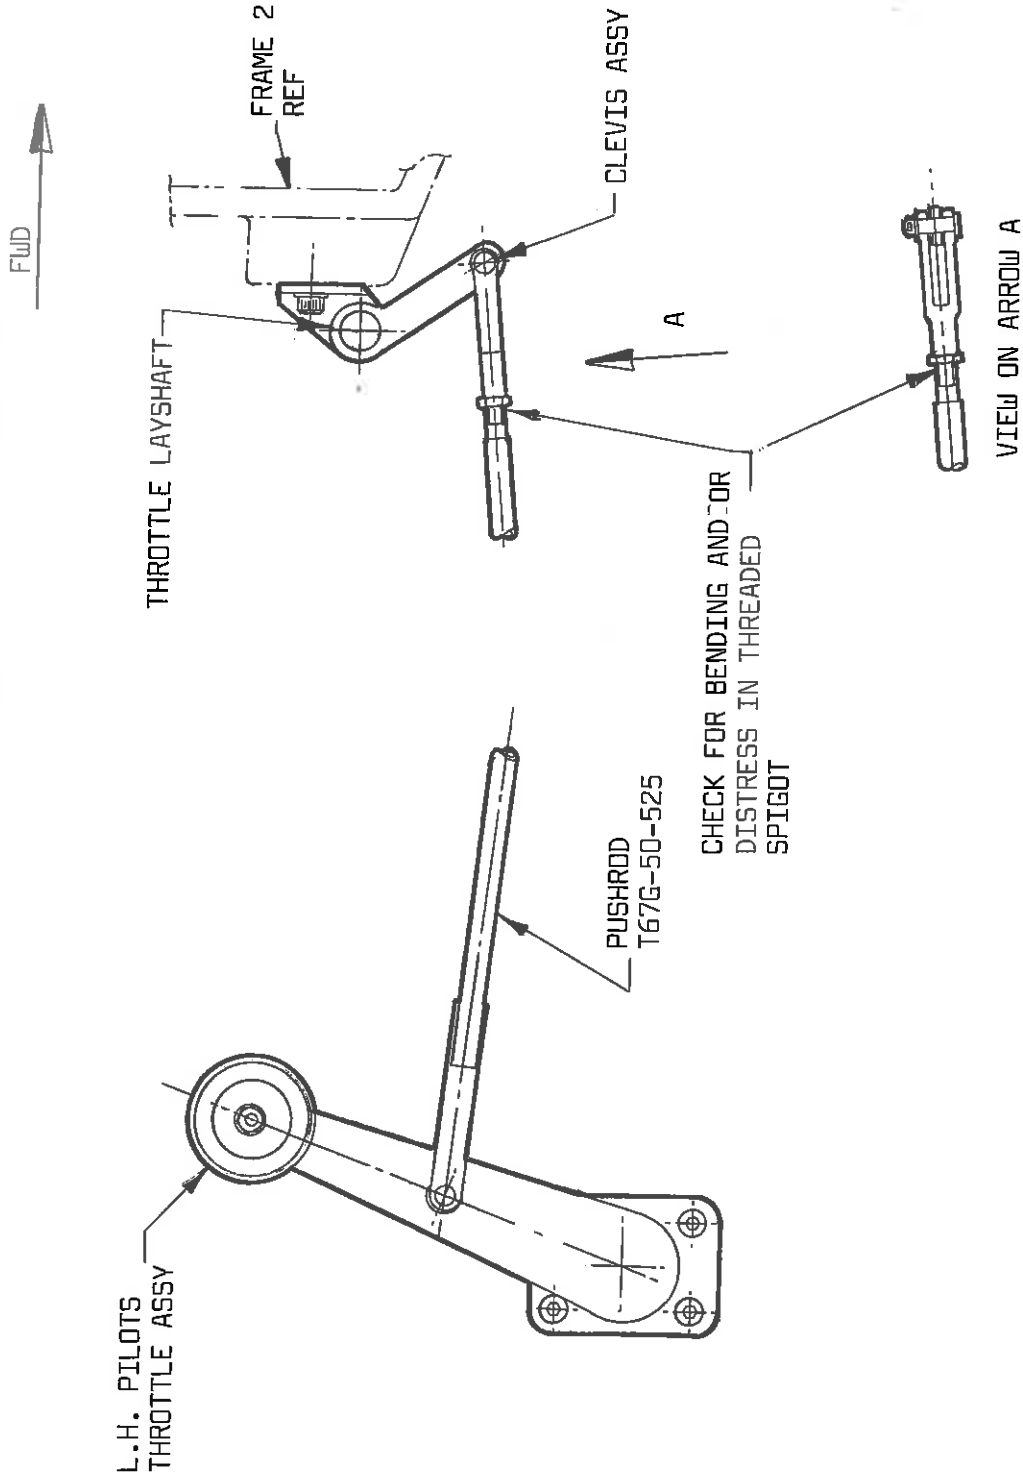
FIG 1
L.H. PILOTS THROTTLE PUSHROD

A case has been reported of a breakage of the left hand pilot's throttle pushrod. On inspection it was found that at the forward end of the pushrod the threaded spigot had broken behind the clevis retaining nut.

On further inspection of other aircraft it was found that the threaded spigots were bent.

It is unlikely that the spigots would become bent in normal flight operations. Deflecting the throttle mechanism during trim panel/seat removal, during maintenance, is a probable cause.

1. Remove throttle pushrod from aircraft and remove clevis assy from pushrod.
2. Check with a straight edge for any bending in the threaded spigot.
3. Check for signs of distress or bending or cracks in threaded portion.
4.
 - i) If spigot is bent or shows signs of any distress or is cracked then renew pushrod Part Number T67G-50-525.
 - ii) If spigot is satisfactory then refit pushrod to aircraft.

5. Annotate log book, "SB 115 complied with".
6. During maintenance should there be a requirement to remove left hand pilots throttle lever assembly, for instance when removing seat and/or trim panels, then throttle pushrod to be disconnected at the throttle layshaft, followed by the throttle lever assembly. This will allow the throttle lever assembly and pushrod to be removed in their entirety. When removing ensure pushrod is not subject to any bending loads.
