SERVICE BULLETIN

68

CANOPY LATCH CORRECT OPERATION INSPECTION

T67M-MkII, T67M260, T67M260-T3A and any T67C, T67M and T67M200 Aircraft Post Mod M129/M129B (Split Canopy),

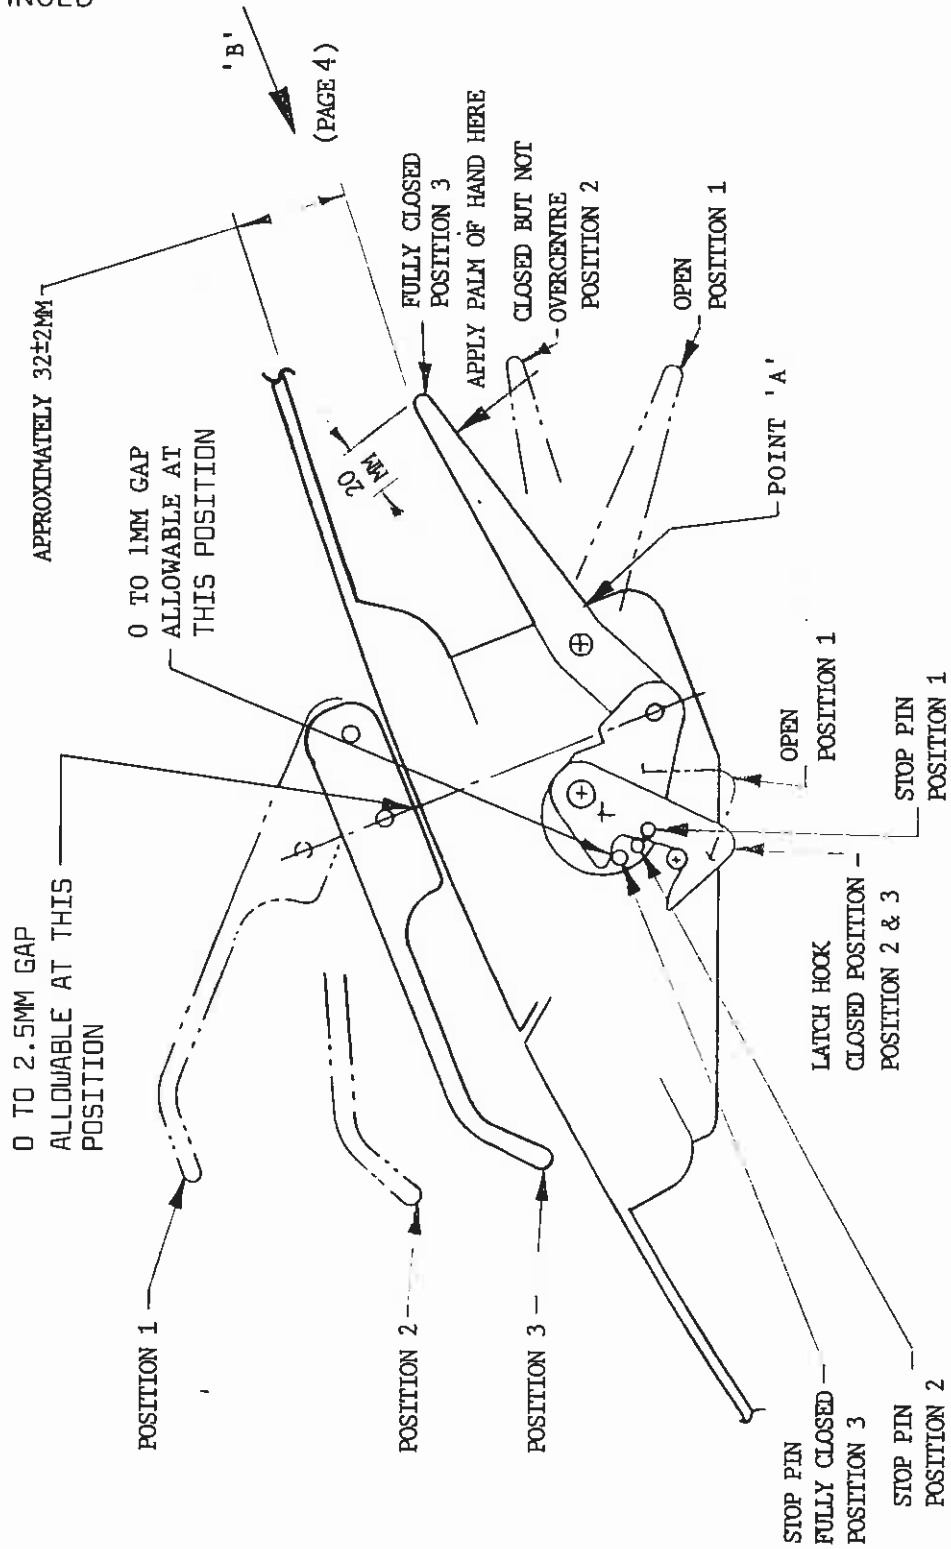
Fig 1

An incident has occurred where the canopy latch was apparently closed correctly but when engine revs were increased beyond 1500 RPM the canopy opened.

Additionally, upon aircraft delivery and on subsequent canopy seal replacement, further incidents have been reported of the canopy lifting off its locating lug/s at high speed. Whilst the canopy does not unlatch, it does cause the pilot some concern. When the speed reduces, the canopy does not settle onto its locating lug/s at the sides, but down to one side causing unnecessary draught and noise.

These incidents have typically occurred within 20 flying hours of delivery of a new aircraft or the fitting of a new canopy seal. Following investigation, the cause was found to be due to the rubber seal taking up a permanent set.

Fig. 1 page 2 shows 3 positions of the canopy mechanism:

Position 1 - Open/Unlatched

Position 2 - Latched but mechanism not over centre

Position 3 - Correctly closed, mechanism fully over centre.

- (i) Remove canopy mechanism and latch covers
- (ii) Close canopy fully. Ensure internal handle is in its correct position and external handle is in its correct position, ie touching bush or no more than 2.5mm gap. Fig. 1.

- (v) Check closure. By positioning palm of hand at point indicated, ref. Fig. 1, push up latch handle, which should close with reasonable resistance but without using excessive force.
