# SERVICE BULLETIN

SB No. 126 Issue No. 1

**TITLE INSPECTION OF PORT RUDDER BAR FOR CHAFING**
**CLASSIFICATION**

T67B, T67C Series, T67M, T67M-MkII, T67M200, T67M260 and T67M260-T3A

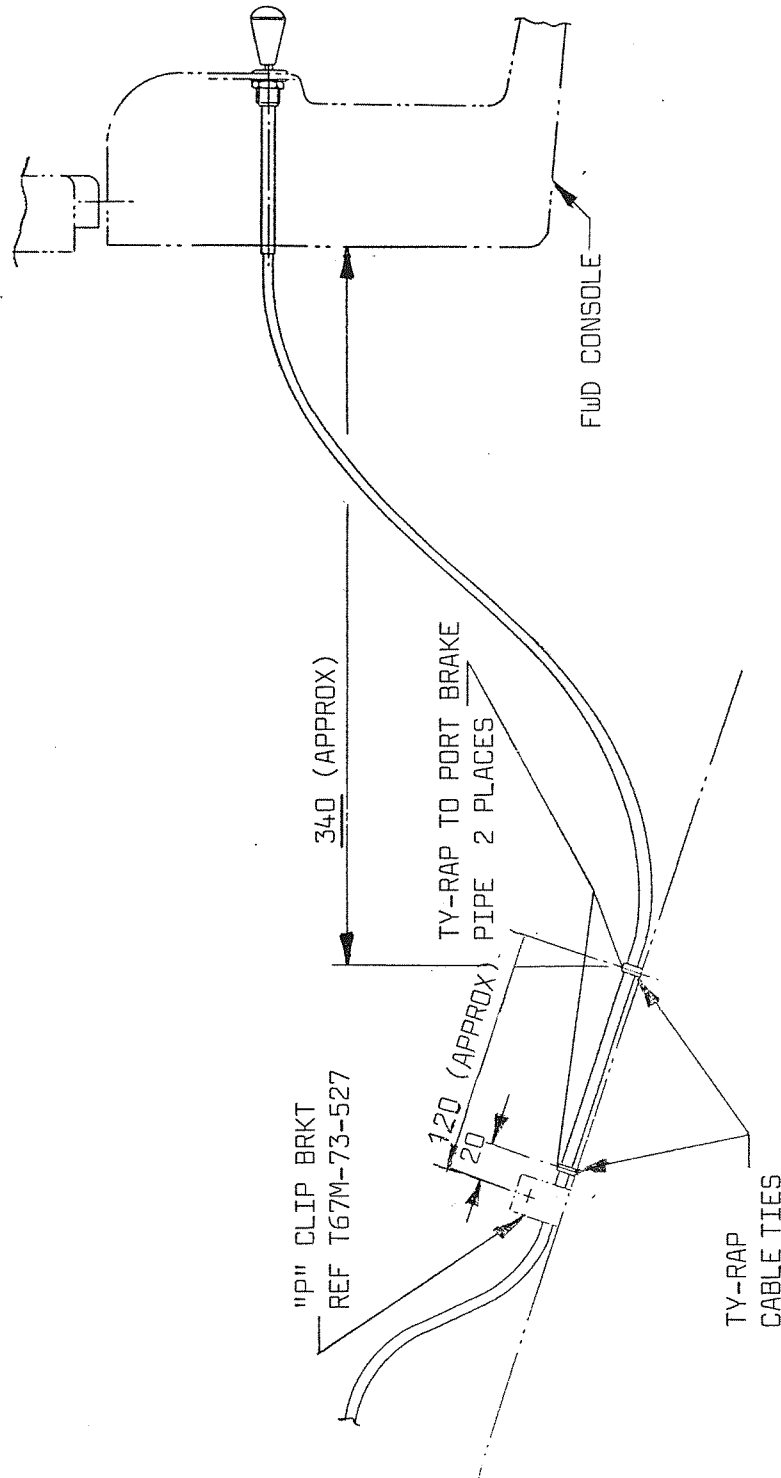
FIG 1  
CORRECT CABLE ROUTING AND TYING

A case has been reported of the hot air control cable fouling and damaging the rudder crossbar due to poor routing.

1. Inspect, using a strong light and a mirror, the lower (port) rudder bar above hot air control cable for signs of chafing.
2. If no chafing has occurred, ensure cable routing conforms to Fig. 1.
3. Should the rudder bar T67M-45-257 be damaged, ie paint removed or grooved to a depth of less than 0.1mm, the rudder bar should be deemed serviceable, repaint damage. A new cable should be fitted according to Fig. 1. Hot air cable Pt No. T67B-74-217 Pre Mod M234, T67B-74-225 Post Mod M234 applicable T67B, T67C Series, T67M, T67M-MkII and T67M200; T67G-74-205 T67M260 and T67M260-T3A aircraft.
4. If rudder bar T67M-45-257 is grooved to a greater depth than 0.1mm, strip down rudder bar assembly and return rudder bar to manufacturer for repair, fit replacement rudder bar. Hot air control cable should be replaced and fitted according to Fig. 1.
