Service Bulletin

S.B. No: 186

Title: INSPECTION OF RUDDER NAVIGATION LIGHT WIRING FOR CHAFFING

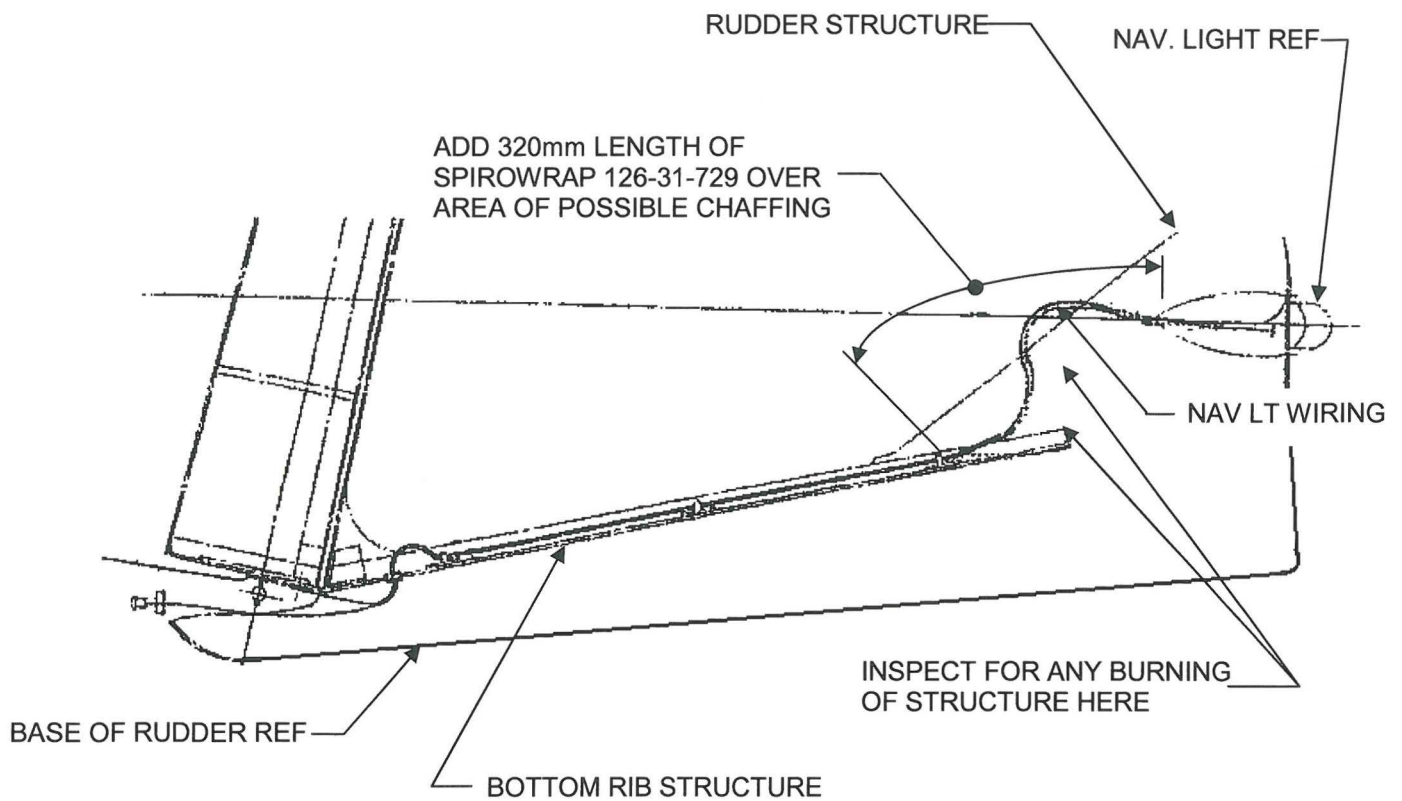
FIGURE 1

A case has been reported of chaffing of a rudder navigation light cable. The cable chaffed through causing the circuit breaker to operate. External inspection revealed evidence of burning on fabric. On removal of navigation light the cable was found to be broken and the lower rudder rib had been burnt which had caused the scorch marks on the outside of the rudder.

- 1 Remove navigation light from rudder by releasing the 2 fixing screws and breaking sealant.
- 2 Carefully withdraw light from rudder.
- 3 Check wiring for any chaffing in area indicated by Figure 1.
- 4 Using a mirror and light check for any signs of rubbing on rudder structure.
- 5 If there is no cable damage then protect wiring as per Figure 1 with Spiral Binding 126-31-729.
- 6 If there is cable damage but no sign of burning, then cable is to be replaced and Change Mod M1025B "Introduction of Tail Navigation Light Wiring Protection Strip on Lower Rib Only and Re-routed Wiring" to be invoked.
- 7 If there is any sign of burning, Rudder to be returned to SACL for structural repair under Change Mod M1025A "Introduction of Repair to Burnt Rudder Includes Tail Navigation Light Wire Protection Strip on Lower Rib and Re-routed Wiring"

- 8 In any case Change Mod M1025B to be invoked at next fabric recovering. Repair Manual to be amended to include wiring condition check and rectification at next amendment.
- 9 Annotate aircraft log book SB 186 complied with.
