SERVICE BULLETIN

SB No. 55 Issue No. 3

TITLE
 SPECIAL INSPECTION OF THROTTLE CABLE - T67 160/200 HP AIRCRAFT

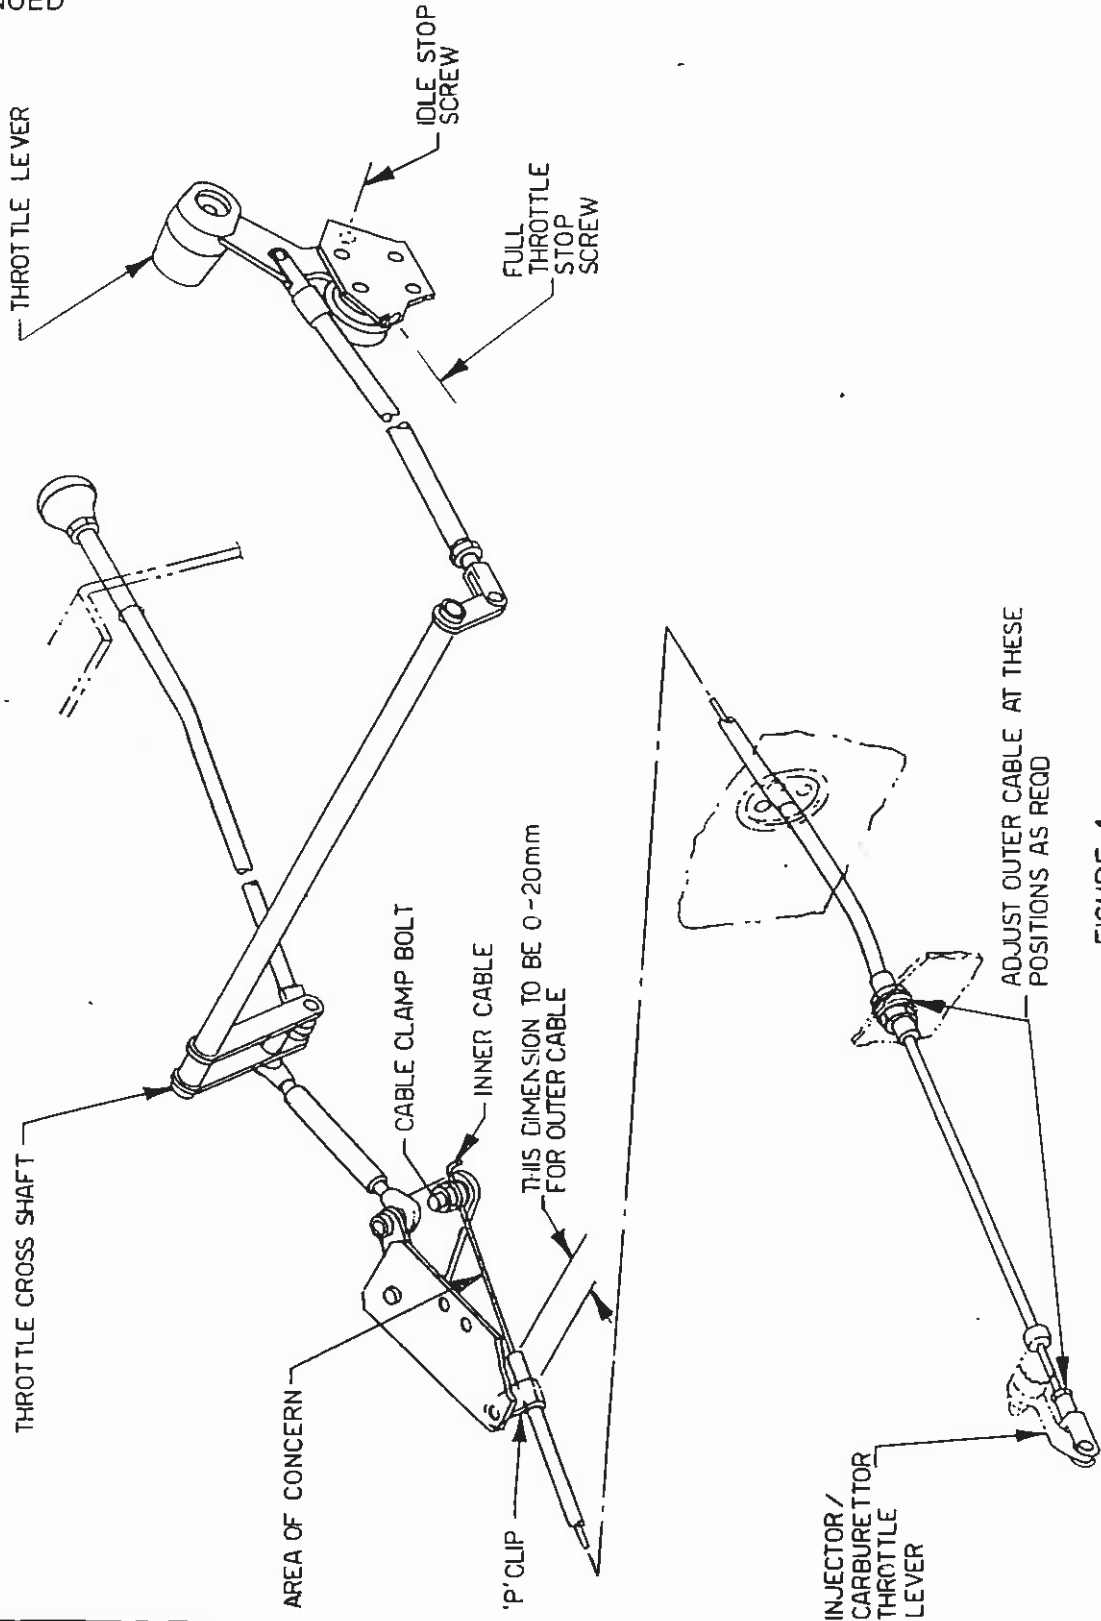
FIGURE 1
(POST MOD M326 DRN)
(T67M & T67M MK II SIMILAR)

There have recently been cases of breakage of the throttle cable on T67 160/200 HP aircraft. In these cases the cable has broken at the cockpit end at a point where the inner cable emerges from the outer cable, see Figure 1.

1. Set the throttle lever to the idle position, and measure the clearance at the idle stop screw.
2. Slacken cable clamp bolt, and disconnect the throttle cable at the carburettor/fuel injector.
3. Withdraw the cable about 2 cm. - this ensures that all the affected part of the inner cable will be visible.
4. Visually examine the inner cable for evidence of kinking or cracking - if either is found the cable must be replaced.

5. Check that the length of the outer cable which extends aft beyond the "P" clip, is between 0 and 2 cm. If necessary, adjust the cable position to lie within this tolerance by slackening the "P" clip, repositioning the cable, and retightening the "P" clip. It may be necessary to also adjust the outer cable clamp position at the engine end of the cable. When retightening the "P" clip, ensure that it is angled to equalize sideways bending of the inner cable during operation.
