SERVICE BULLETIN

SB No. 105 Issue No. 1

TITLE
INSPECTION OF CONTROL SURFACES FOR RUBBING MARKS
CLASSIFICATION

T67B, T67C Series, T67M, T67M-MkII, T67M200, T67M260 and T67M260-T3A.

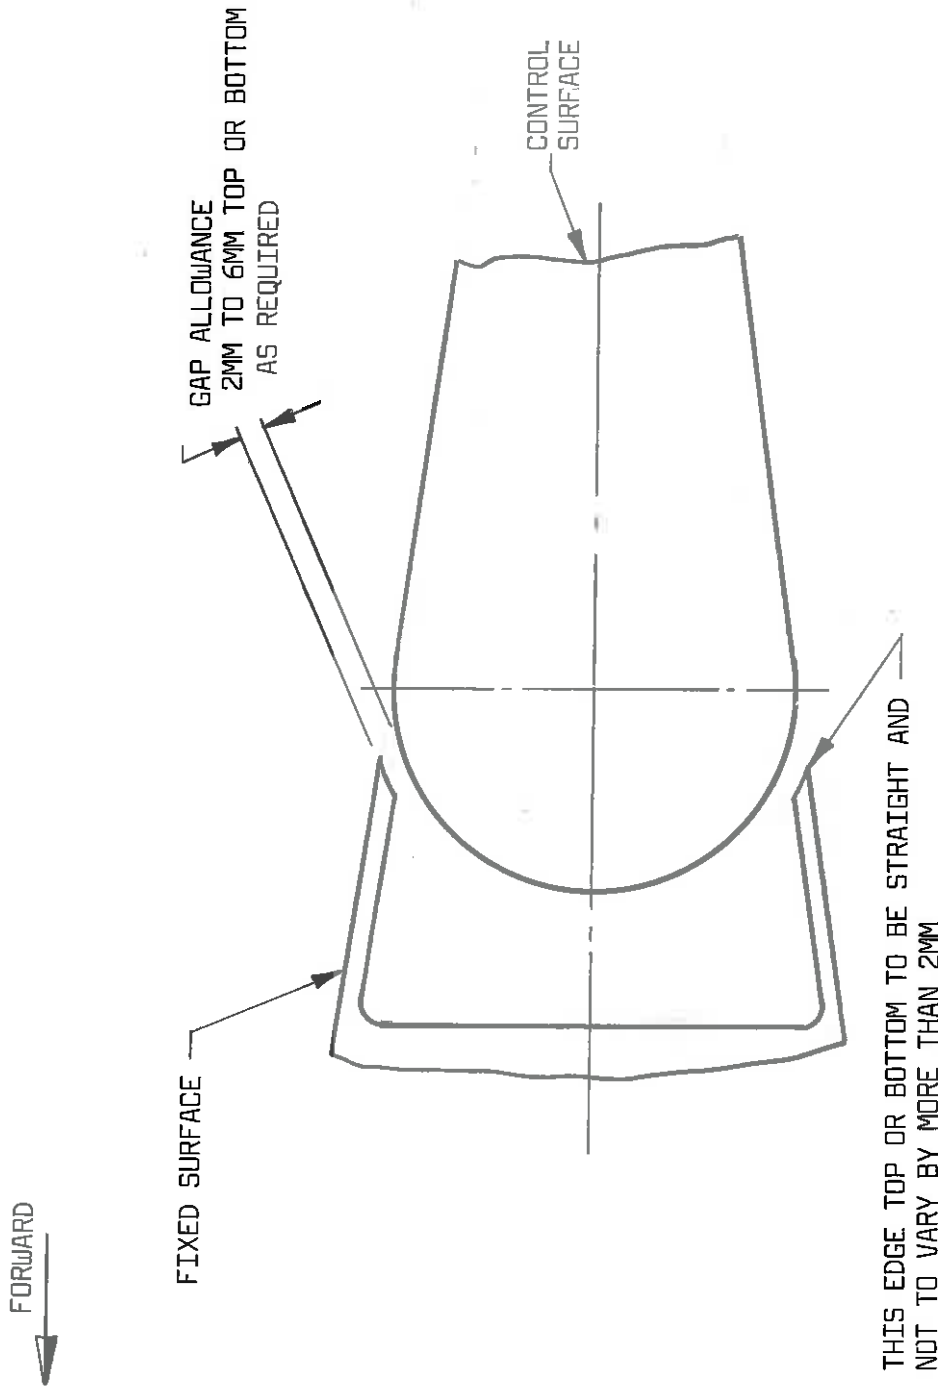
FIG 1
SECTION BASED ON ELEVATOR
FLAP ANDAILERON SIMILAR

Cases have been reported of control surfaces rubbing the shrouds of the fixed flying surfaces. The rubbing is mostly likely to occur when high g manoeuvres are undertaken in hot climatic conditions.

1. Check for rubbing marks on aileron, flap and elevator leading edges.
2. If there is evidence of rubbing between shroud and control surface then the gap may be increased by abrading relevant control surface shroud, ref. Fig. 1.

The shroud to control surface gap increase is to be kept to a minimum. Maximum allowable gap is to be 6mm. Gap along its length not to vary by more than 2mm. Gap to be measured when control surface is in the neutral position.
