# SERVICE BULLETIN

SB No. 53 Issue No. 1

**INSPECTION OF AIR INJECTOR BOX AUXILIARY INTAKE DOOR SPRING ATTACHMENT BRACKET**

All T67M260-T3A type aircraft.

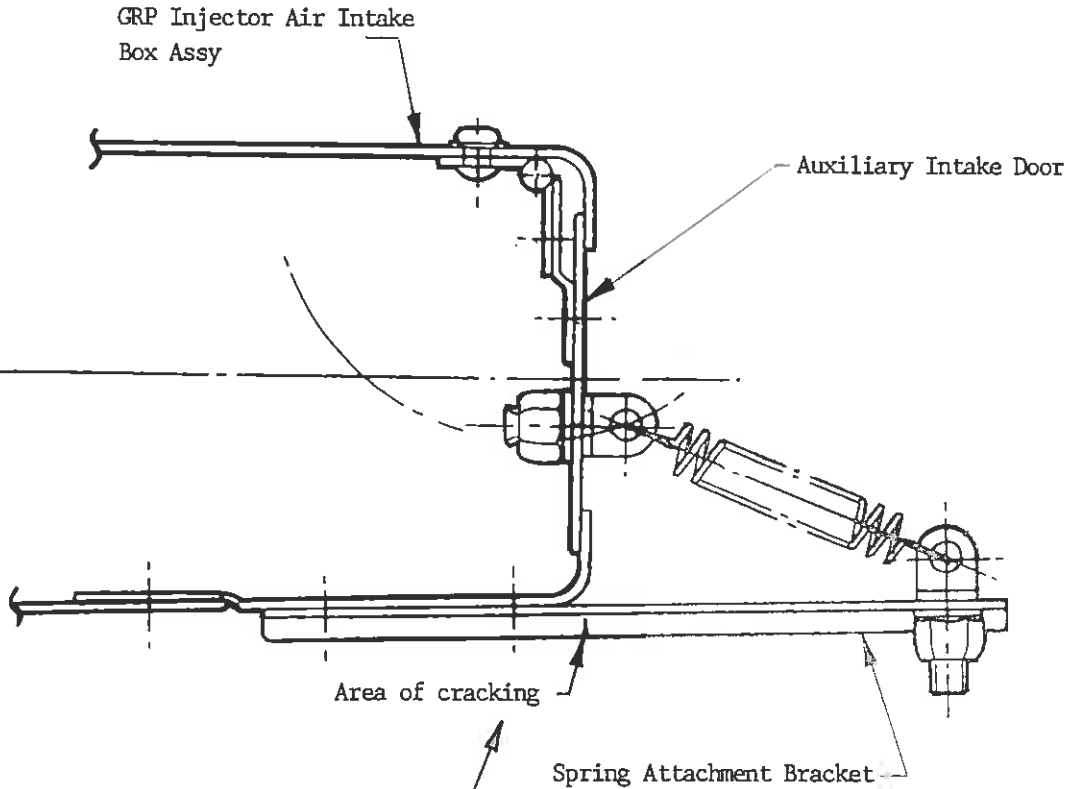
Fig 1

An incident has occurred where spring attachment bracket at the rear of the air injector intake box has fractured. This is possibly due to the bracket being struck by the cowling during fitting. See Fig.1.

1. Inspect bracket at position indicated on Fig. 1.
2. If a crack is detected fit M596.
3. If a crack is not detected inspect every 25 hours until Mod M596 incorporated.
