**Service Bulletin**

S.B. No: 188

**Title:** INSPECTION FOR RUDDER PEDAL CLEARANCES BETWEEN RUDDER PEDALS AND THE AIRCRAFT STRUCTURE AND COMPONENTS

**Applicability:** T67B, T67C series, T67M (excluding works no. 1999), T67M-MkII and T67M200 (excluding works no. 2264 & 2265).

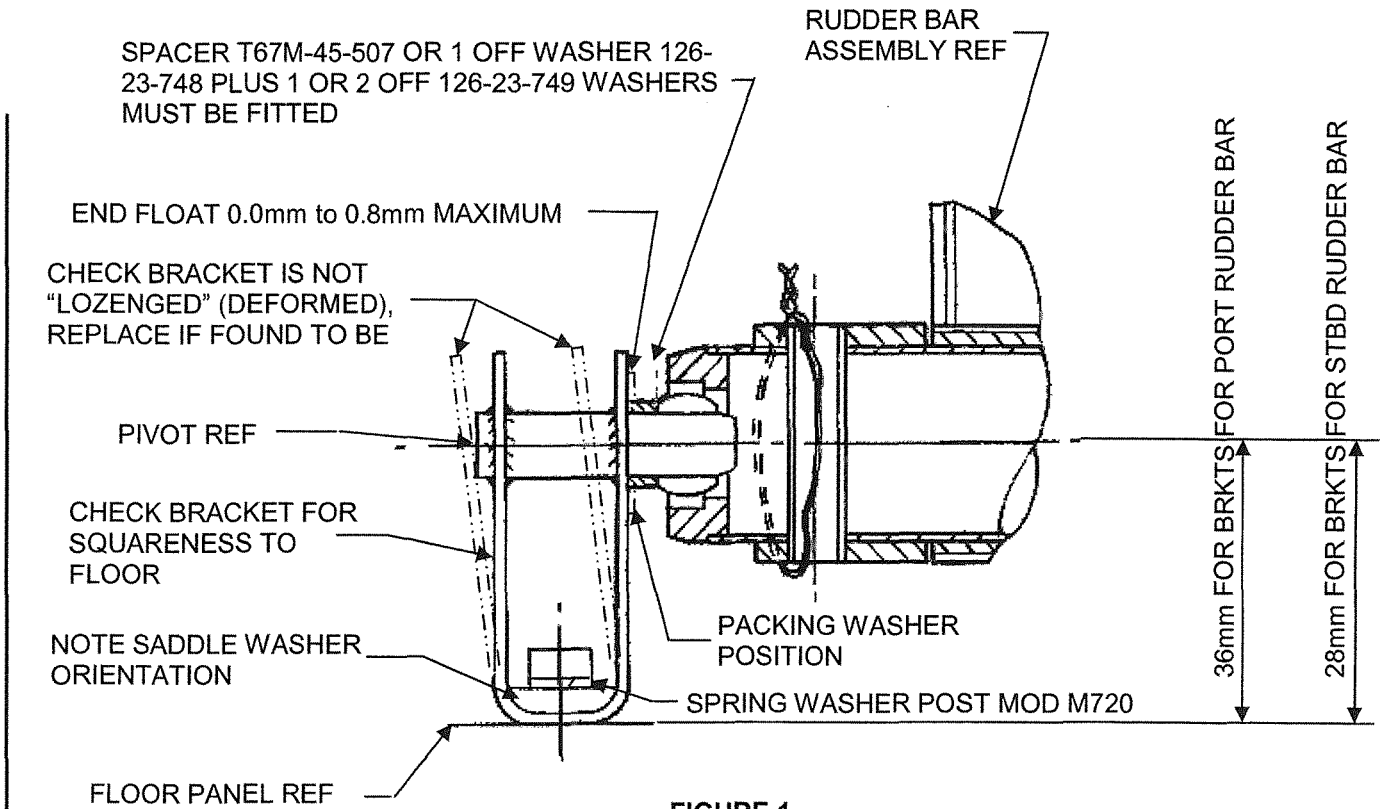
3. Check rudder pedal bar end float is no greater than 0.8mm. Acceptable end float is 0.0mm to 0.8mm. If end float is greater than 0.8mm then rectify end float IAW paragraph 8. Refer Figure 1.

RUDDER BAR END FLOAT AND ITS SUPPORT BRACKET

8. Referring to Figure 1 ensure at each rudder bar pivot position that there is one spacer T67M-45-507 OR one off washer 126-23-748 and up to a maximum of two off washers 126-23-749, i.e. 3 washers maximum.

- If end float greater than 0.8mm, then 1 off packing washer may be added at each pivot position as required, i.e. 126-23-105 washer or 126-23-748 washer or 126-23-749 washer.

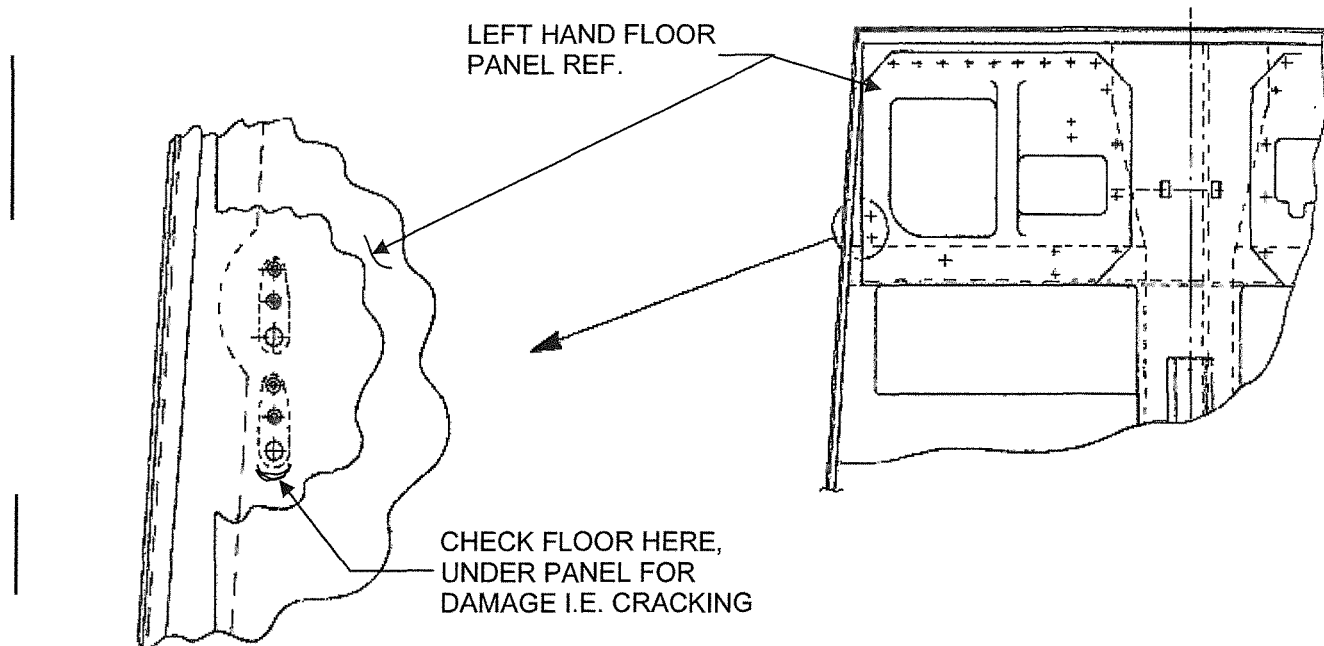
4. Check that the Rudder Pedal bar port outboard support bracket, ref. Figure 1 and 3, is square to the floor and not "lozenged" and there is no deformation to its base. Check floor panel under area of bracket, inspect for cracking which could allow the bracket to lean. If necessary remove floor panel and check for signs of cracking in the floor around the anchor nuts on Pre Mod M919 aircraft or the anchor nut mounting plate Post Mod M919 aircraft, refer Figure 2. Any GRP damage will be shown as a white shadow on the GRP, with cracking felt as a rough edge. A light shining up through the floor will show a shadow.

AREA OF FLOOR REQUIRING INSPECTION (PRE MOD M919 DRAWN)

5. If floor under port outboard support bracket is found to be cracked or broken then repair IAW DOI T67C-149 incorporating Mod M919. If Mod M919 has been previously incorporated and floor is damaged inform SACL.

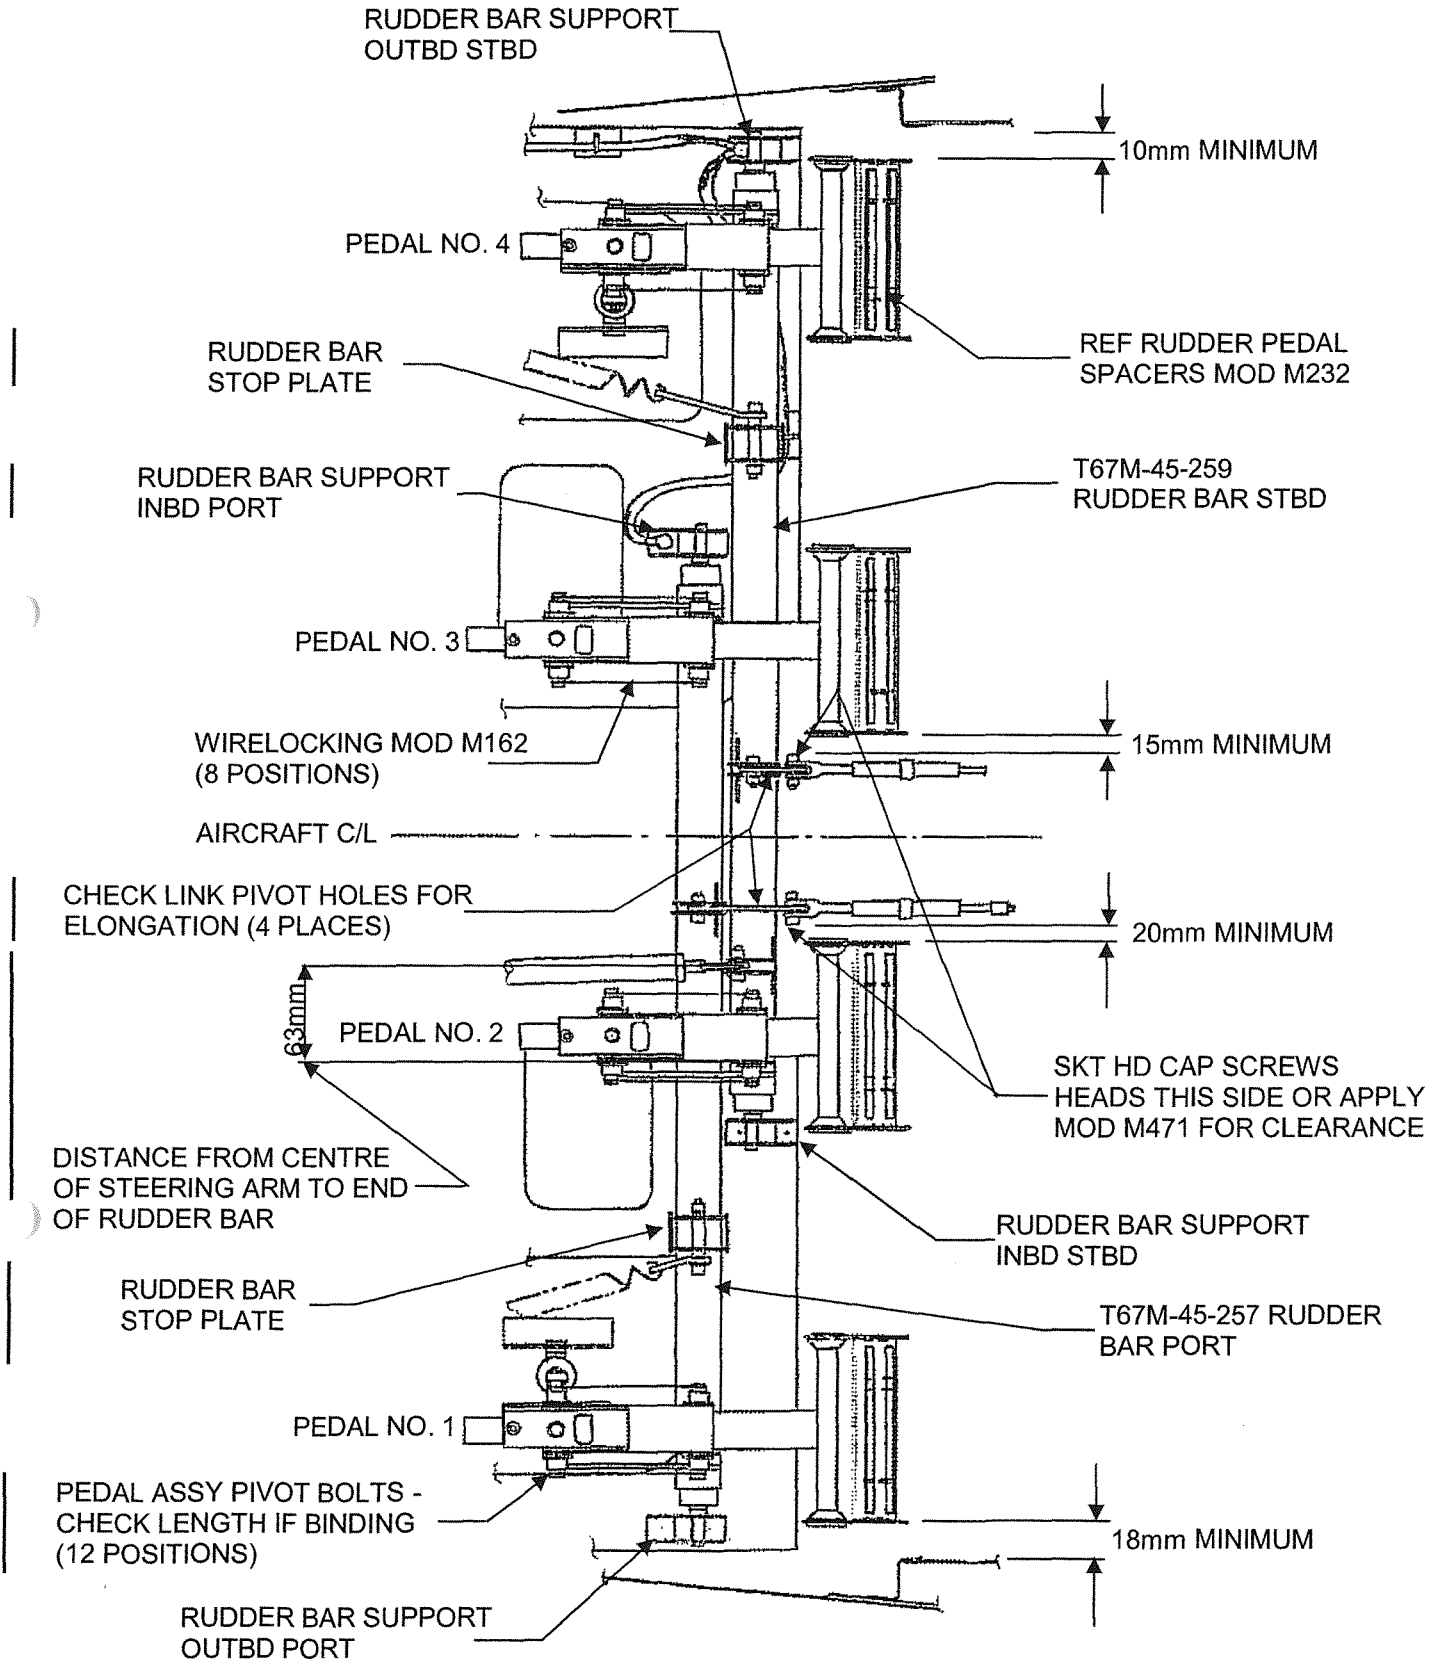
FIGURE 3

7. Check the remaining rudder bar support brackets, ref. Figure 3, are square to floor and are not "lozenged" and there is no deformation to their bases, reference Figure 1. If any bracket is found to be suspect replace with new item. Check floor under any damaged support bracket by removing panel. Ensure washers and brackets are correctly assembled refer paragraph 6 above. Inform SACL of any damaged bracket or additional floor damage. Assemble item as per paragraph 6 and ensure end float is as stated in paragraph 8. Ensure bonding leads are correctly fitted, carry out bonding check refer relevant aircraft's Maintenance Manual.

13. Upon completion of rudder movement set-up ref. Paragraph 11 above. Ensure minimum clearances of trim panel to pedal side plates and rudder cable to pedal side plates are met Figure 3 refers. If necessary to obtain the required clearances, Mod M232 "Introduction of Rudder Pedal Packing for Increased Clearance of Surrounding Components" may be required to be invoked. Refer paragraph 7 for packing washers on rudder bar.

### RUDDER PEDAL CLEARANCES TO SIDE PANEL AND RUDDER CABLES

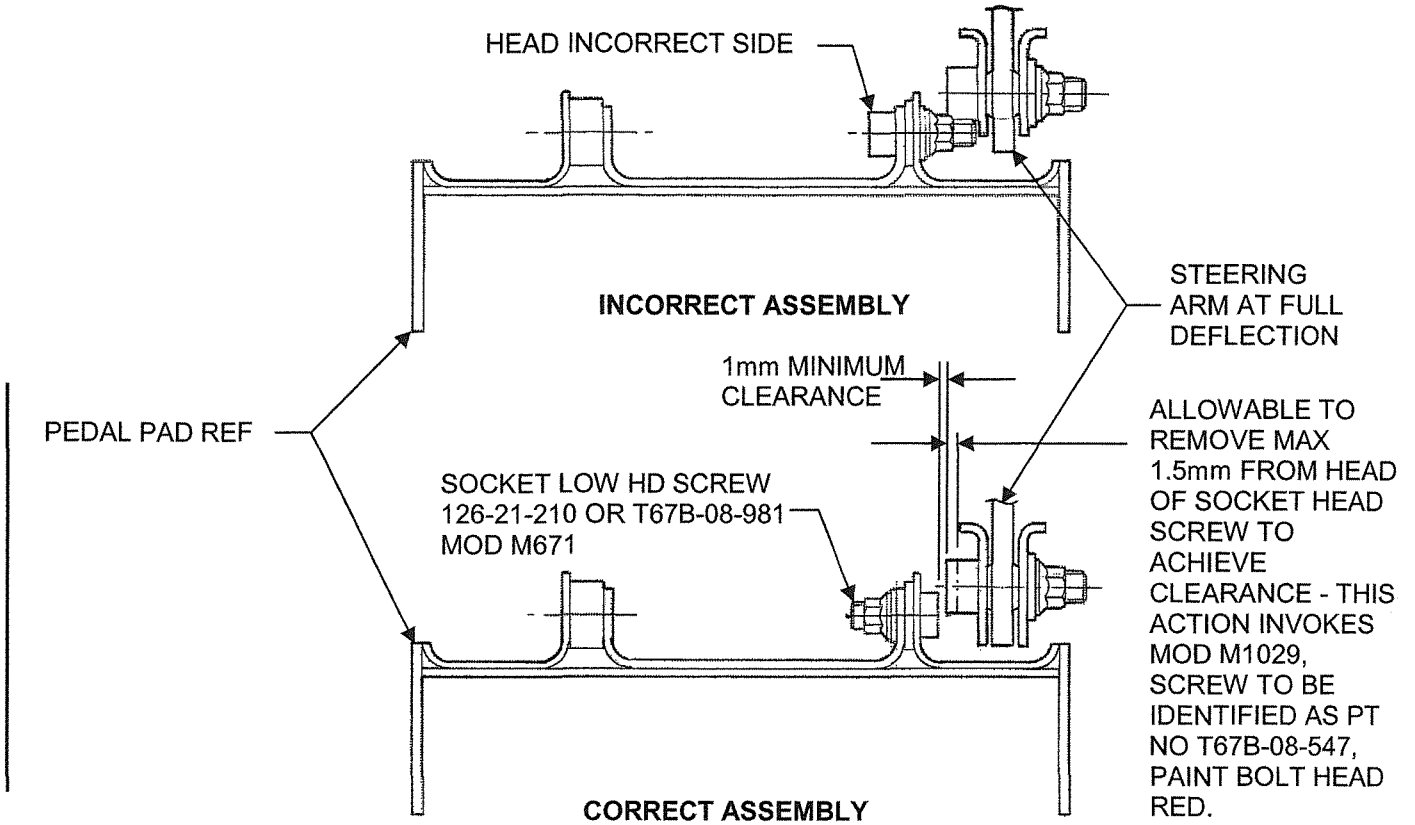
FIGURE 4

16. Ensure Pedal no 2 Pedal pad pivot bolt head height is less than 5mm and orientated as shown in Figure 4. A minimum of 1mm clearance is required, if not fit part no 126-21-210 or T67B-08-981, this invokes Mod M671 "Introduction of Low Head Rudder Pedal Pad Pivot Bolts – Pedal No. 2". If clearance is not still achieved check distance of steering arm from bar end, Figure 3 specifies. If the distance is incorrect, then return rudder bar to SACL for re-worked/new item. Alternatively if clearance of 1mm is still not achievable remove up to a maximum of 1.5mm from the steering arm screw this invokes Modification action M1029, Figure 4 refers, and paint modified screw head red.

### PEDAL NO. 2 TO STEERING ARM INTERFACE

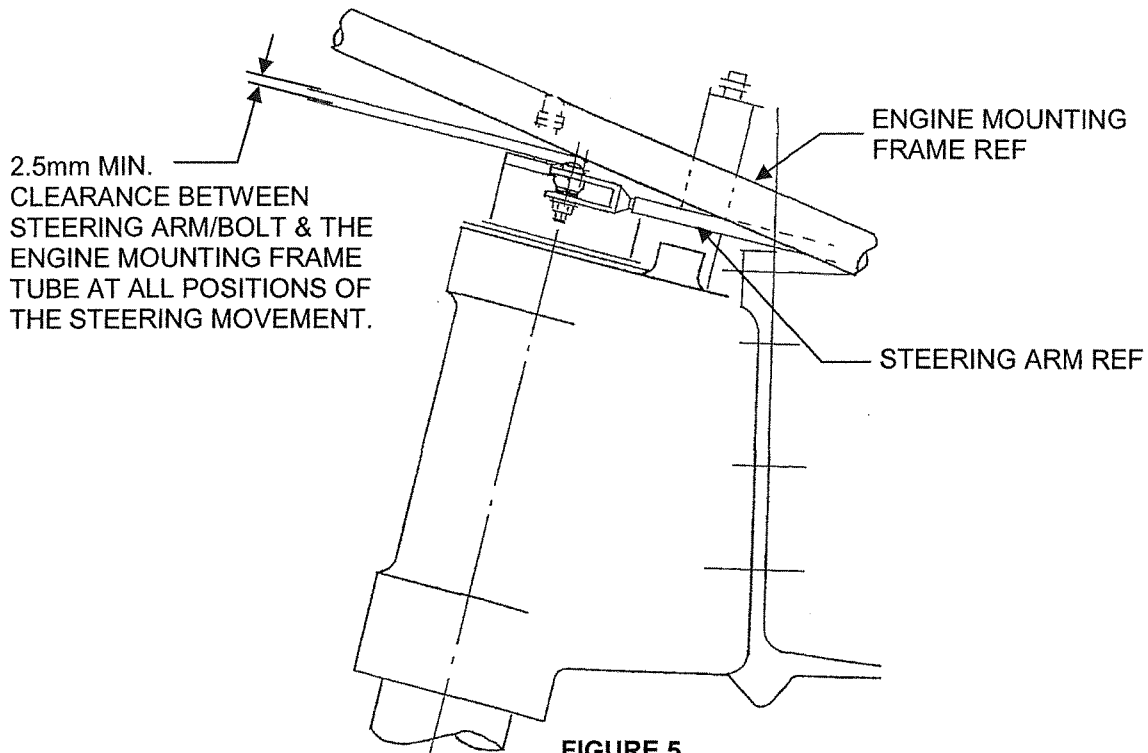
FIGURE 5

21. Ensure on aircraft fitted with the Fairey Hydraulic undercarriage, (Post Mod M468 or Mod M791), that there is a minimum clearance of 2.5mm with steering linkage to engine mounting frame, see Figure 5. Ensure there is no damage to engine mounting frame if clearance is less than 2.5mm. If engine mounting frame is damaged then aircraft must not be flown until damage is rectified, consult SACL. Also if clearance is less than 2.5mm embody Mod M575 "Introduction of Offset Steering Arm Pin – Ref Fairey Hydraulics Nose U/C", if Mod M575 is fitted and clearance is less than 2.5mm inform SACL.

### STEERING ARM ENGINE MOUNTING FRAME CLEARANCE

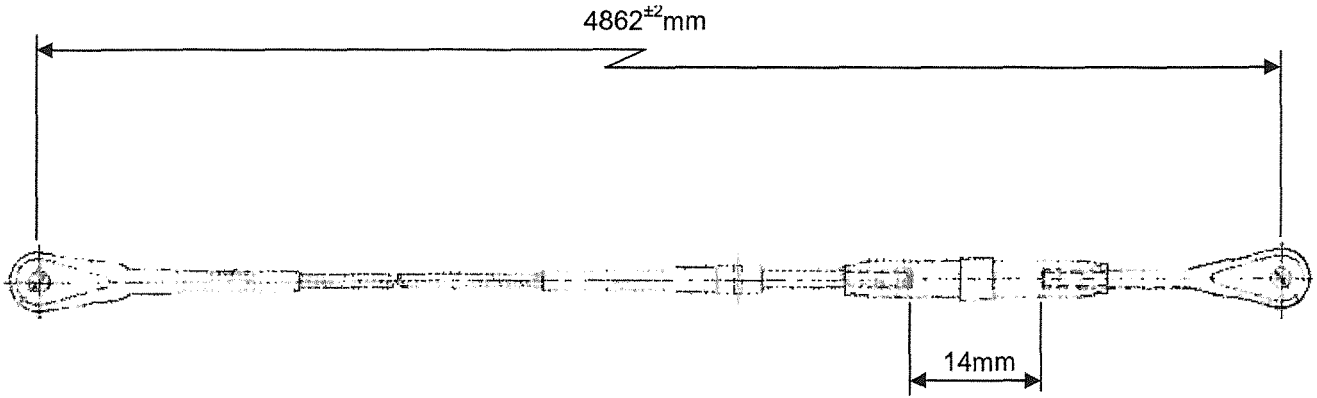
**FIGURE 6**

14. Ensure fuel pipe to rudder pedal slider clearance of is met, refer relevant aircrafts Maintenance Manual Paragraph, 5.6.5.1, where relevant the minimum acceptable clearance is now to be 5mm. If clearance cannot be achieved then; i) remove Rudder Cable and check length, length should be 4862  $\pm$  2 mm, Figure 6 refers; ii) additionally check condition of rudder pedal assembly, refer paragraph 2.

**RUDDER CABLE T67B-45-219  
(ORIGINAL MANUFACTURED DIMENSIONS QUOTED)**

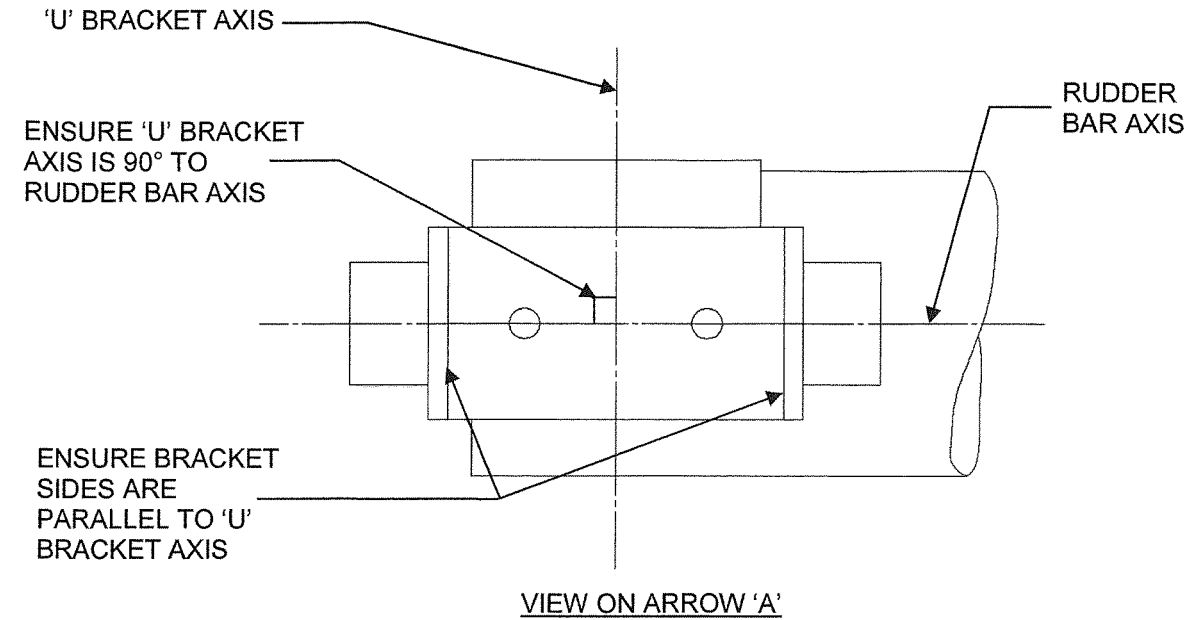
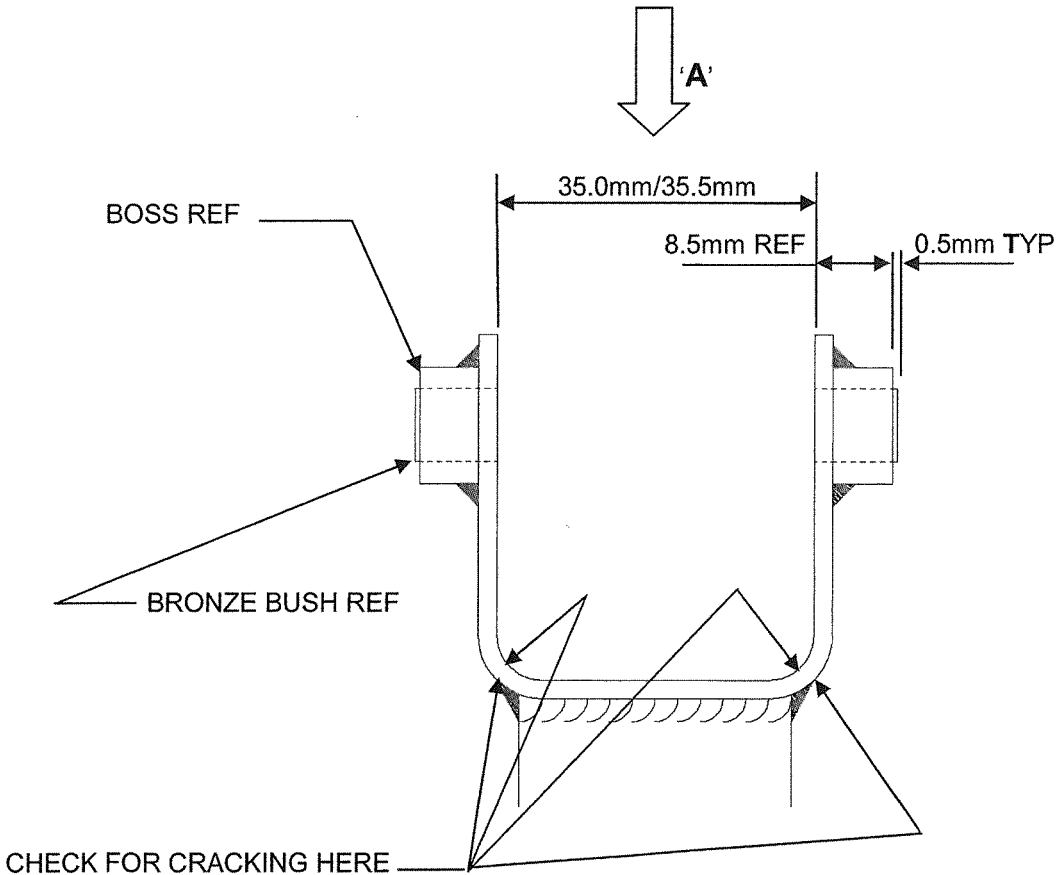
FIGURE 7

9. Ensure the rudder pedal carriages have full and free movement. If binding is suspected then check the 'U' bracket internal dimension. This should measure 35.0mm to 35.5mm, the bracket should also be parallel and square to the rudder bar axis, Figure 7 View on 'A' refers. Check that the pivot bush protrudes from its boss by 0.5mm. If the bracket internal dimension is greater or less, or if out of alignment then the bracket should be checked for cracking, refer Figure 7. If cracking is found then return rudder bar to SACL for rework. Finally check length of carriage pivot bolts, reference Figure 3, if binding is noted then replace bolts with bolt part number T67B-08-537 this introduces a bolt 15 mm long, measured from under head, and invokes Mod M808 "Introduction of Shortened Pivot Bolt to Rudder Pedal Slider Assembly Mounting". Also refer to SB130 Inspection of Rudder Pedals for Adjustment Restriction".

'U' BRACKET ON RUDDER BARS  
(4 POSITIONS)

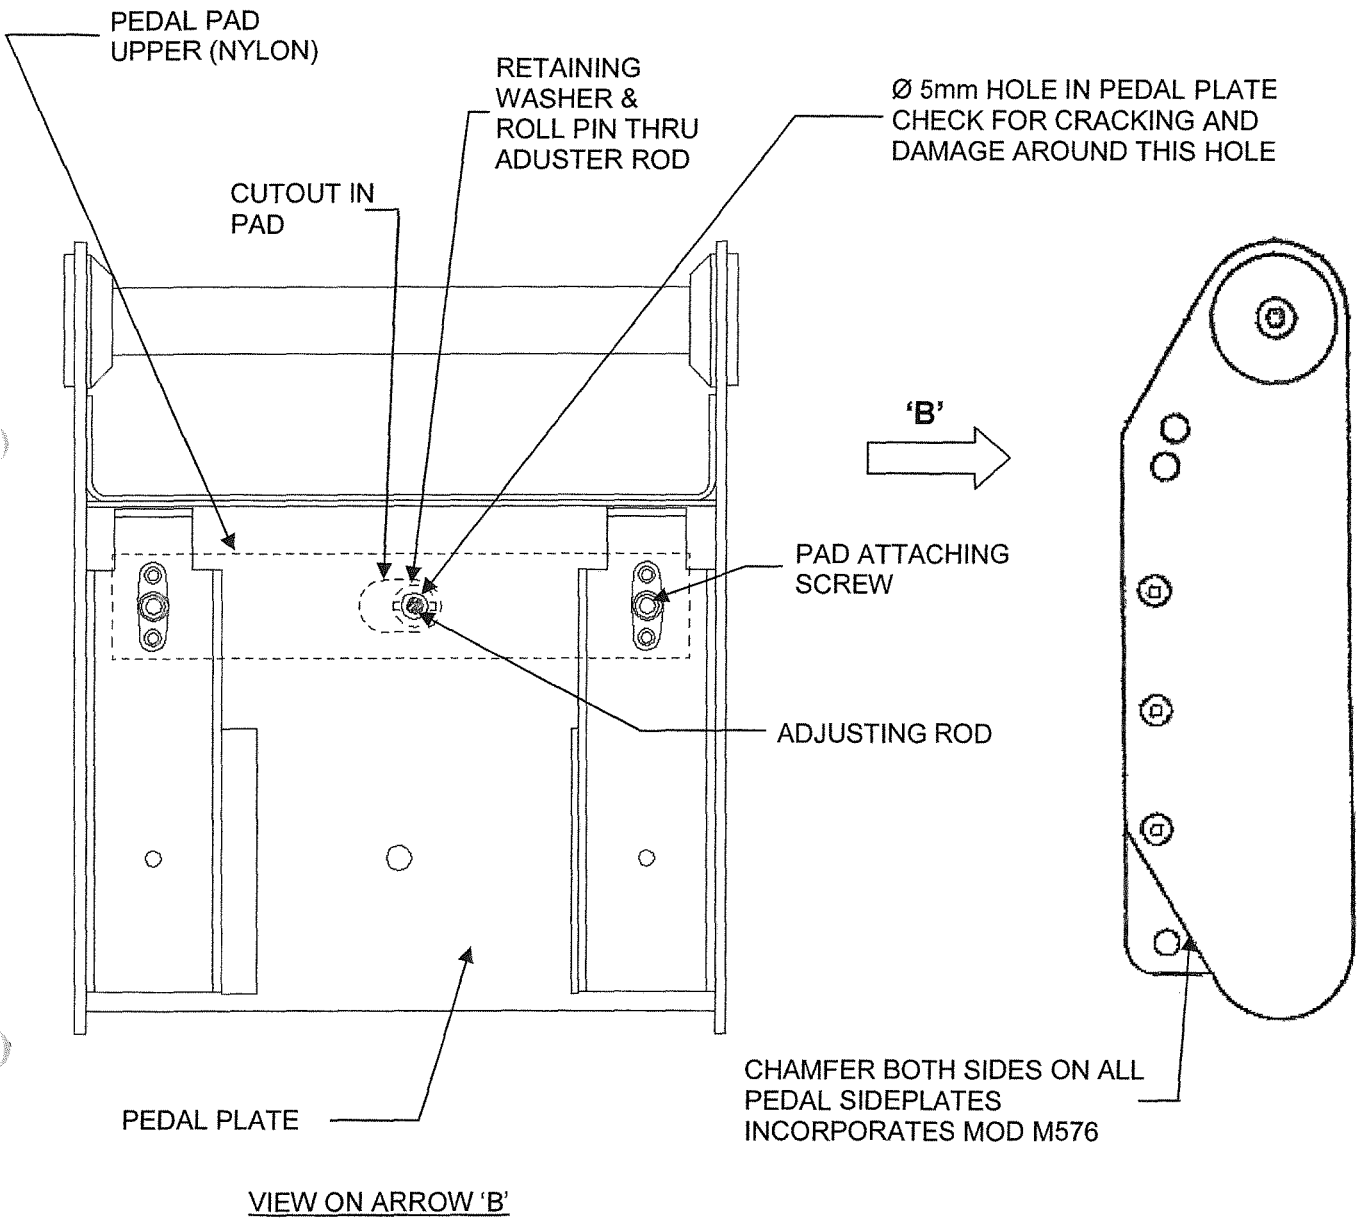
FIGURE 8

18. Ensure Mandatory Mod M576 has been invoked; AD 013-05-94 refers. Pedal side plate should be as Figure 8.
19. Check structural integrity of pedal pad assembly especially around adjuster pushrod hole pedal plate, Figure 8 View on Arrow 'B' refers, if plate is cracked or damaged the pedal pad is to be repaired. Ensure riveting is secure, if rivets are loose then they have to be rectified. Contact SACL for new pedal pad assembly, materials and any applicable repair scheme.

MOD M576 PEDAL SIDEPLATES WITH CHAMFER
