SERVICE BULLETIN

SB No. 133 Issue No. 1

TITLE INSPECTION OF FLAP LEVER PIVOT ATTACHING POINT FOR CRACKING

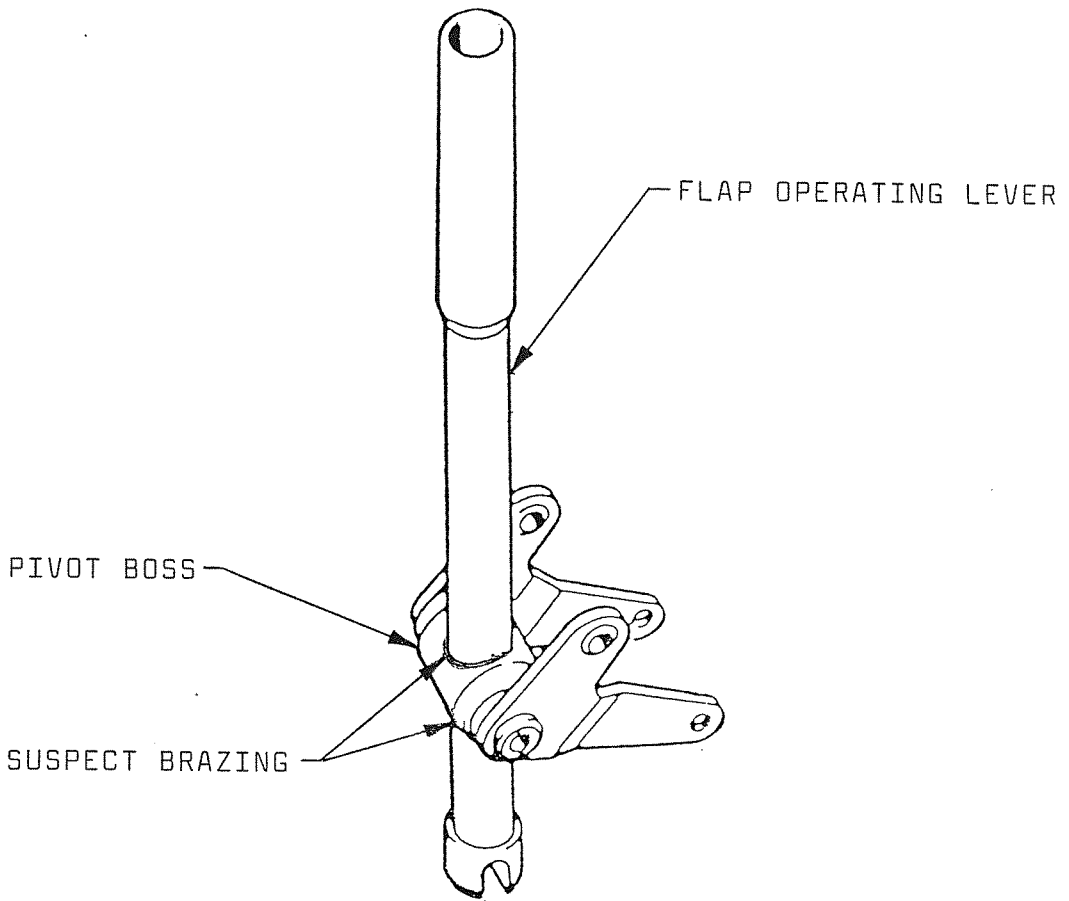
FIGURE 1 FLAP OPERATING HANDLE
(ITEMS DELETED FOR CLARITY)

Cases have been reported of cracking in the brazed joints above and below the lever pivot point.

1. Gain access to the flap lever pivot boss.
2. Establish whether flap lever is brazed or welded. If in doubt, remove paint from joint. Welded joint will be the natural metal colour. If welded joint identified, restore finish. Annotate Log Book, "SB 133 complied with". If brazed joint identified, continue as para 3 below.
3. Inspect, using strong light and mirror, all brazing between lever and pivot boss, above and below pivot.
 - i. If no cracking present, certify item as serviceable. Annotate aircraft log book, "Service Bulletin No.133 complied with". Re-inspect at 150 (100 U.S.) flying hours.
 - ii. If brazed joint is found to be cracked, remove flap lever assembly, strip down flap lever completely and replace lever with Part No.T67B-45-262.
