**SERVICE BULLETIN**

SB No. 155 Issue No. 1

TITLE**INSPECTION FOR FOUL BETWEEN CANOPY SLIDE RAIL PIVOT BOLT
AND FUSELAGE SPLASH SHIELDS****CLASSIFICATION****This Service Bulletin has been classified by SAL as Highly Recommended****COMPLIANCE****At next 150 flying hour check or 100 flying hour check, as applicable****APPLICABILITY:****T67M-MkII, T67M260, T67M260-T3A.
Post Mod M129 T67C, T67M and T67M200.****INTRODUCTION:**

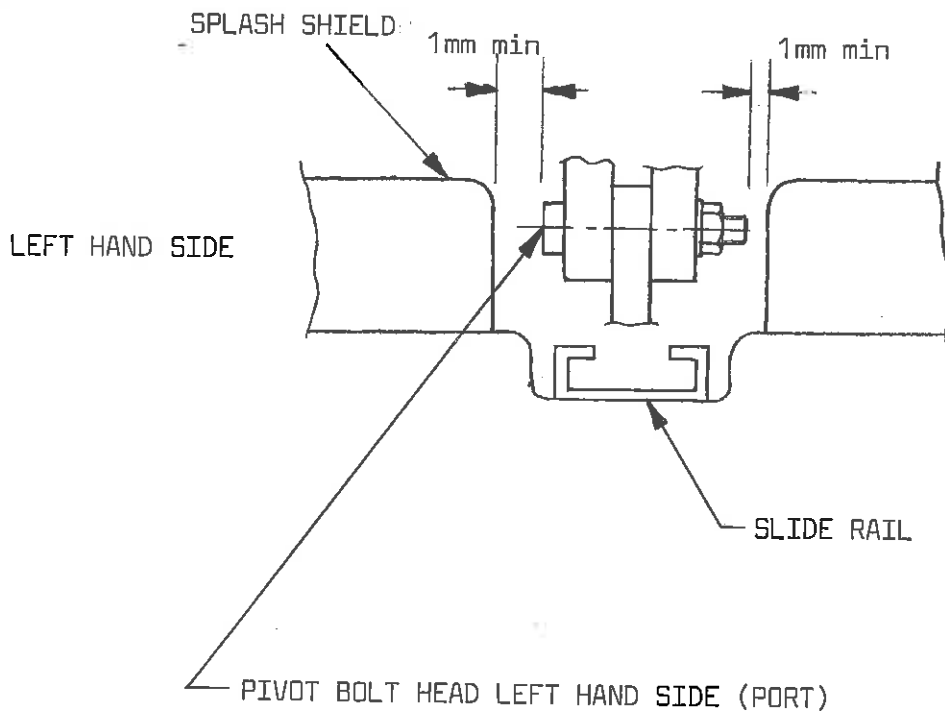
FIG 1 - CANOPY SLIDE RAIL
VIEW LOOKING FORWARD

A case has been reported of the canopy slide rail pivot bolt (socket head cap screw) fouling with the GRP splash shields. This SB requires a one time inspection and, if necessary, a modification.

1. Ensure canopy slide rail has its head on left hand (port) side of the slider.
2. Open canopy and inspect bolt and fuselage splash shields for clearance.
3. If the clearance is greater than 1mm, ref Fig 1, no further action need be taken. If a foul has occurred or clearance is less than 1mm, a repair is to be invoked to increase splash shield clearance.
4. If applicable, repair i.a.w. Mod M843 on receipt of Mod Bulletin.
5. Annotate logbook "SB 155 complied with" on satisfactory inspection.

For Mod Bulletin Mod M843, materials and further information, please contact SAL Product Support Department.
