**SERVICE BULLETIN**

42

INSPECTION TO AILERON SUPPORT RIB OUTBOARD (RIB 8)

All T67B, T67C, T67M, T67M MKII, T67M200, T67M260 aircraft.

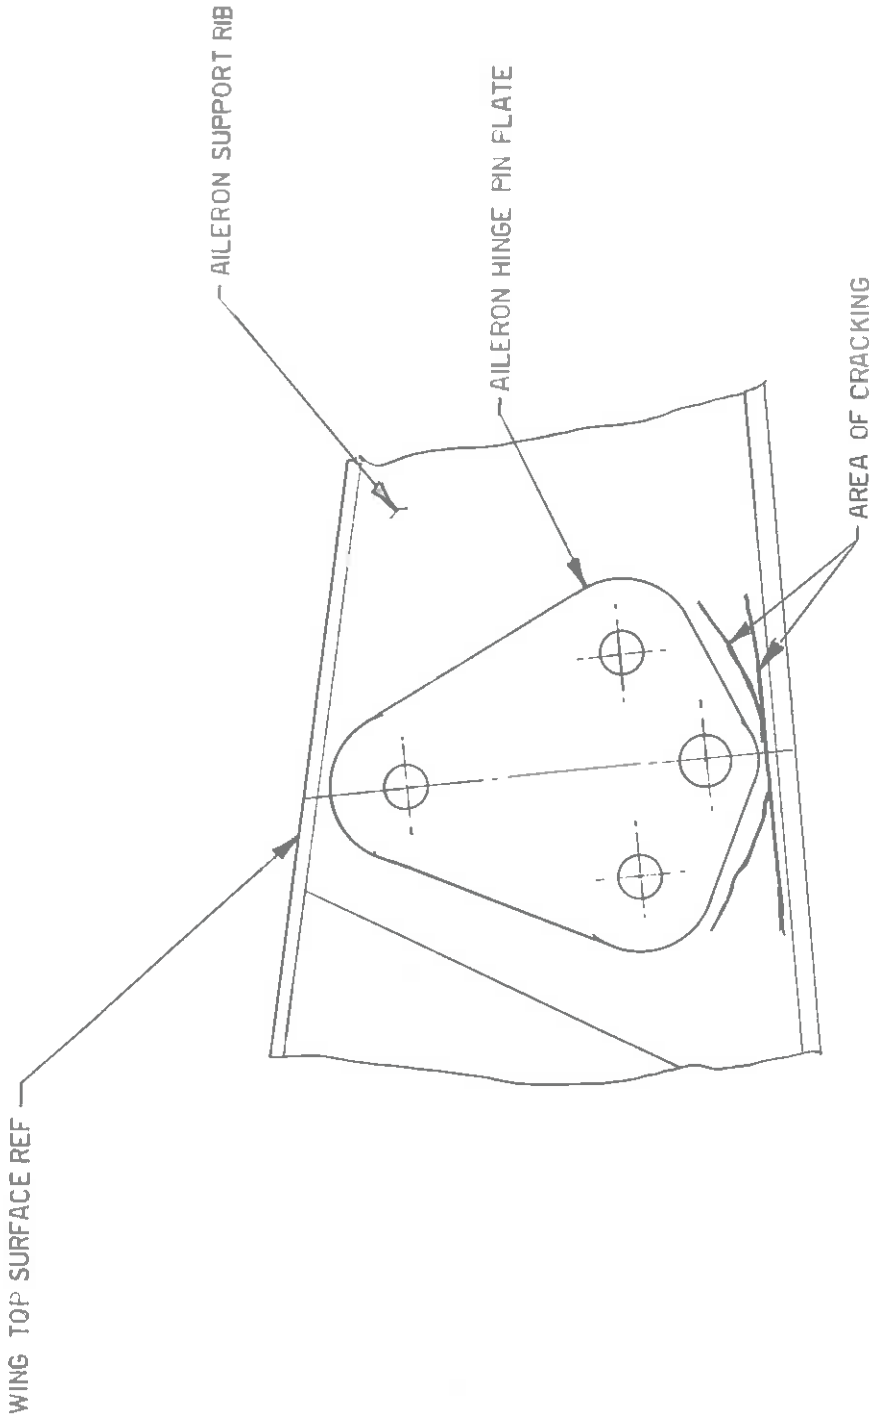
FIG.1
STBD DRN. PORT SIMILAR

There has been a reported case of excessive sideways movement of the aileron which when investigated led to the inspection of the outboard wing rib (Rib 8), whereupon small cracks were found below the aileron hinge fitting. (Ref. Fig. 1).

1. Remove small access plug at aileron outboard hinge (both wings). Carefully remove any loose paint from area below hinge plate. Clean both sides of rib.
2. Visually inspect for cracking. If there is no obvious sign of a crack use a strong light, eg torch, and shine on opposite side of rib from initial visual inspection. Any evidence of a crack will show up as a shadow. If in doubt apply a sideways force on to the rib at hinge point, any excessive movement of rib will indicate a crack.
3. If no cracking is found, see Action - Repeat Inspections.
4. If rib cracked, the aircraft must not be flown until Mod M510 is incorporated or an acceptable approved alternative repair scheme is carried out.
5. Report findings to SAL Customer Service Department.

At every 150 hours repeat inspection at 1. above. If cracks are found, carry out actions 4 & 5.
