SERVICE BULLETIN

SB No. 41 Issue No. 2

TITLE
SPECIAL INSPECTION OF THROTTLE CABLE - T67B AIRCRAFT
CLASSIFICATION

All T67B aircraft.

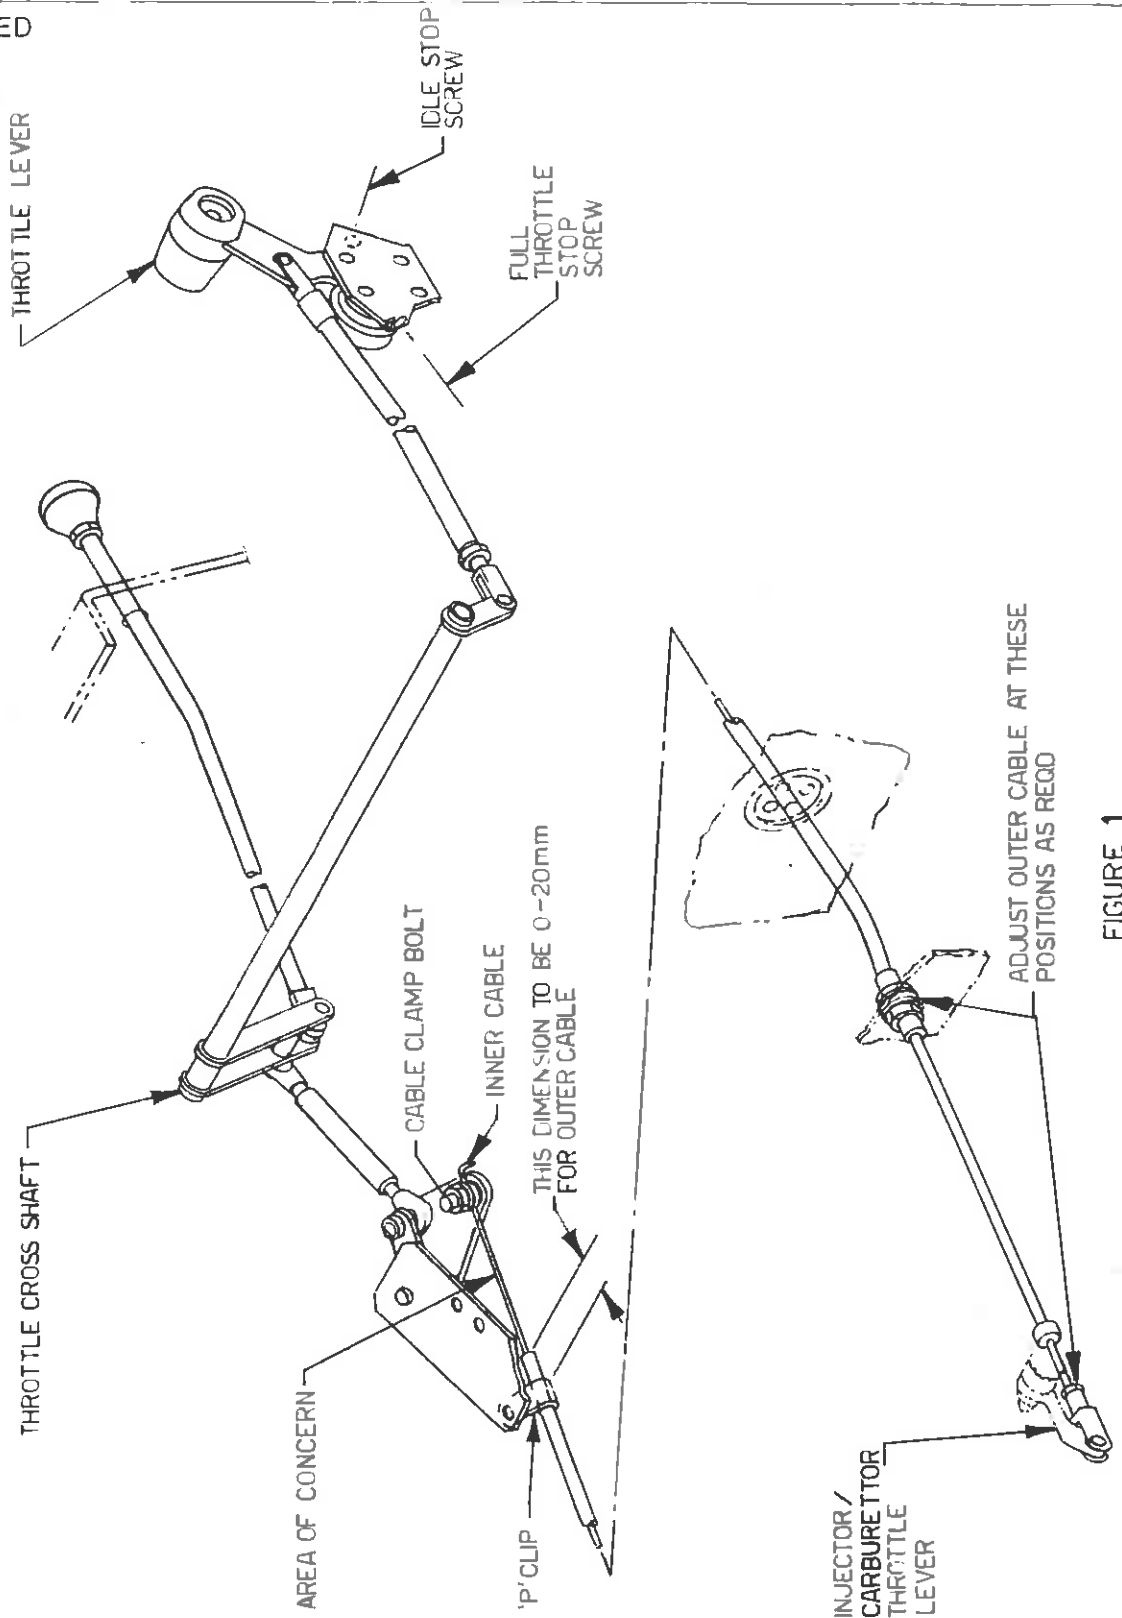
FIGURE 1
(POST MOD M326 DRN)

There have recently been cases of breakages of the throttle cable on 160 HP and 200 HP T67 aircraft. In these cases the cable has broken at the cockpit end at a point where the inner cable emerges from the outer cable, see Figure 1.

1. Set the throttle lever to the Idle position, and measure the clearance at the Idle stop screw.
2. Slacken cable clamp bolt, and disconnect the throttle cable at the carburettor/fuel injector.

3. Withdraw the cable about 2 cm. - this ensures that all the affected part of the inner cable will be visible.
4. Visually examine the inner cable for evidence of kinking or cracking - if either is found the cable must be replaced.

5. Check that the length of the outer cable which extends aft beyond the "P" clip, is between 0 and 2 cm. If necessary, adjust the cable position to lie within this tolerance by slackening the "P" clip, repositioning the cable, and retightening the "P" clip. It may be necessary to also adjust the outer cable clamp position at the engine end of the cable. When retightening the "P" clip, ensure that it is angled to equalize sideways bending of the inner cable during operation.
