Aircraft Type: Slingsby T67 Firefly (T67A, T67B, T67C, T67C3, T67M, T67M Mk11, T67M200, T67M260, T67M-T3A)

Title: Slick Service Bulletin SB1-15A – Potential of decreased service life of Slick 4-cylinder magneto distributor gear assemblies.

SUBJECT: Potential decreased service life of Slick 4-cylinder magneto distributor gear assemblies. **Based on process and component improvements following the initial release of this service bulletin, the serial number range is being extended in this revision. Magnetos previously returned for compliance to SB1-15 must be returned or inspected for compliance to this revision SB1-15A.**

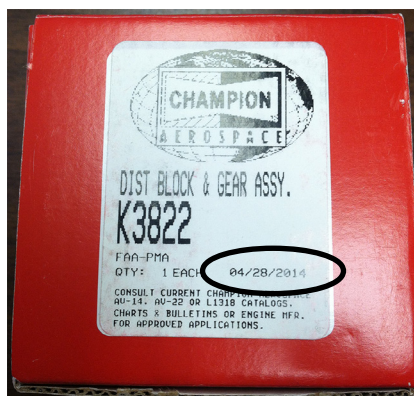
Figure 1. Replacement Kit Box Label Date Code

- Any 4200 series, 4300 series or 4700 series (LASAR) magnetos which have had the distributor block assembly replaced with a K3822 distributor block replacement kit dated **Sept. 26, 2008 thru Sept. 1, 2016** installed as part of a repair
- Individual K3822 distributor block replacement kits dated **Sept. 26, 2008 thru Sept. 1, 2016**
- Individual K3008 distributor gear replacement kits dated **Sept. 26, 2008 thru Sept. 1, 2016**

COMPLIANCE: REMOVE affected distributor gear assembly in subject magnetos and REPLACE with replacement distributor gear assembly, K3008, as soon as possible, not to exceed the next 50 hours. Document Service Bulletin compliance as written entry in applicable Aircraft and/or Engine logbook.

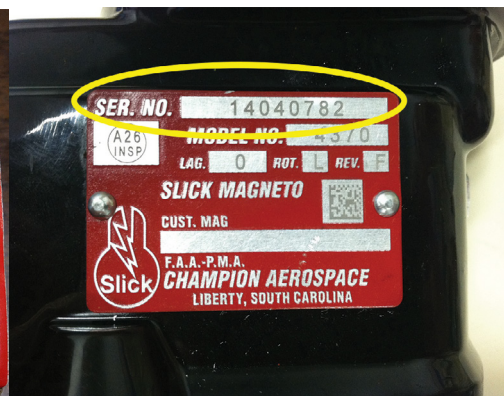
Figure 2. Magneto ID Label Date Code

AFFECTED: The following 4-cylinder magnetos with serial numbers between **08090001 thru 16071072**, K3822 distributor block replacement kits, and K3008 distributor gear assemblies dated **September 26, 2008 thru September 1, 2016:**

NOTE: **08090001 = SN manufacture date of September 2008 and 16071072 = SN manufacture date of July 2016**
