Service Bulletin

S.B. No: 187

Title: INSPECTION FOR CLEARANCE BETWEEN RUDDER PEDAL AND MIXTURE/PROP. SPEED BRACKET AND FOR GROUND TOWING DAMAGE. ALSO INCLUDES GENERAL RUDDER PEDAL CLEARANCES.

Applicability: T67M200 (Works No. 2264 & 2265 only), T67M260 and T67M260-T3A.

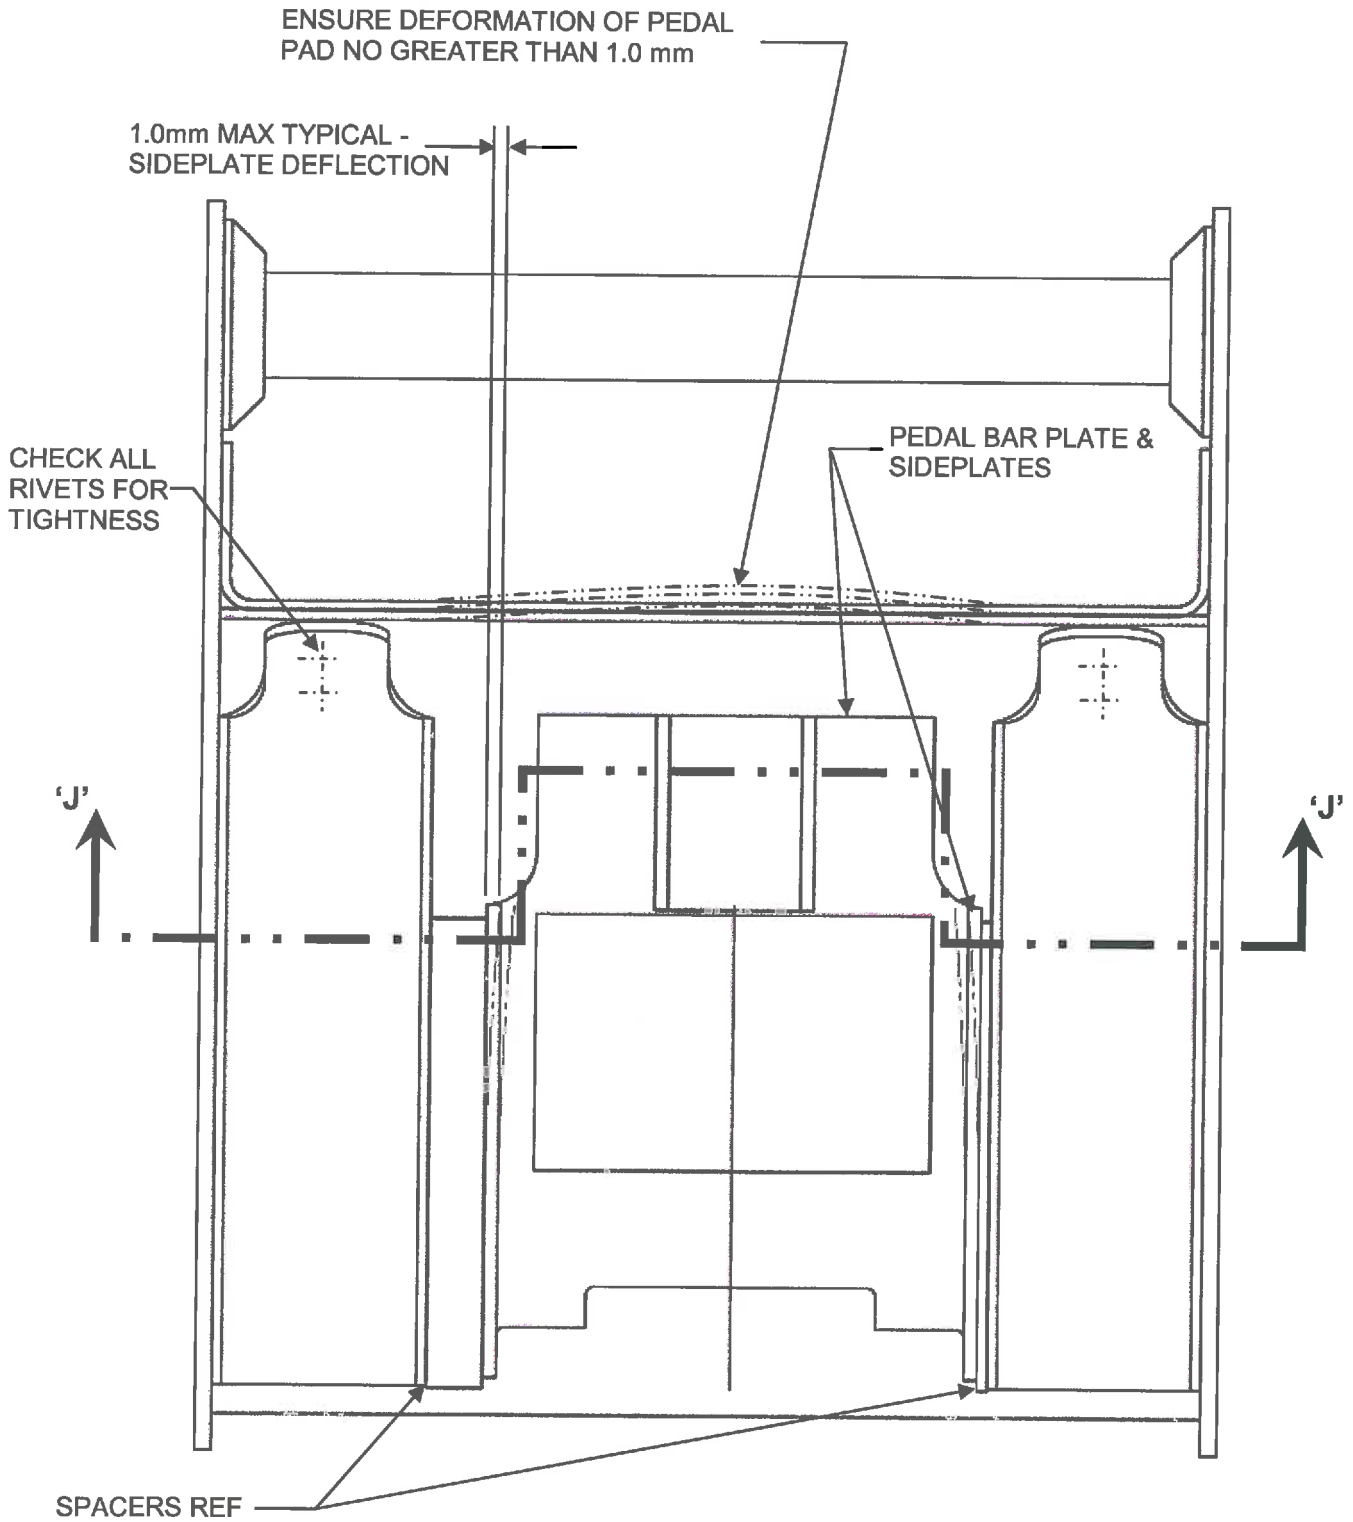
FIGURE 14

Note: When carrying out aircraft ground running at high RPM it is advisable to use effective chocks wherever possible and not rely upon the aircraft brake system alone because the aircraft may be dragged along with the wheels locked. In this situation, any further pressure on the brake pedals will be ineffective and cause damage to the rudder pedal pads, support plates and sliders. Typical deformation found is shown at Figures 14, 15 and 16. If any similar damage is found, part/s are to be returned to MSAC for rectification.

SECTION 'G-G' (REFER FIGURE 4)

**SHOWING SECTION THROUGH PEDAL ASSY NO. 3
(NOTE PEDALS 1, 2, & 4 SIMILAR)**

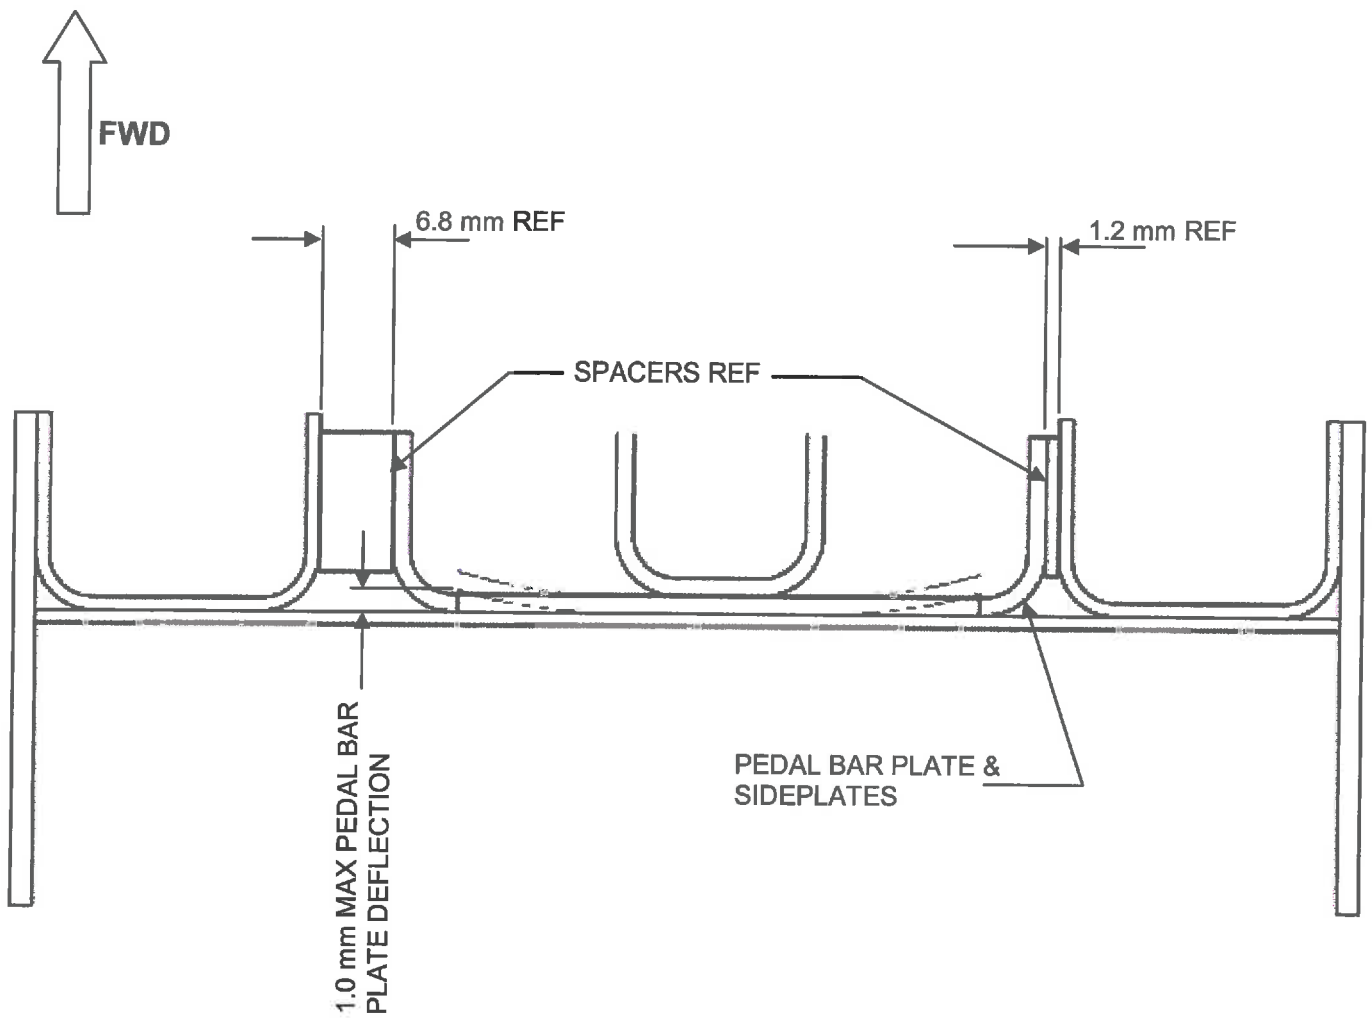
FIGURE 15

VIEW ON ARROW 'J' (REFER FIGURE 14)

**SHOWING VIEW ON FORWARD FACE OF PEDAL
(NOTE: APPLICABLE TO ALL PEDALS)**
