# SERVICE BULLETIN

SB No. 53 Issue No. 1

**INSPECTION OF AIR INJECTOR BOX AUXILIARY INTAKE DOOR SPRING ATTACHMENT BRACKET**

All T67M260-T3A type aircraft.

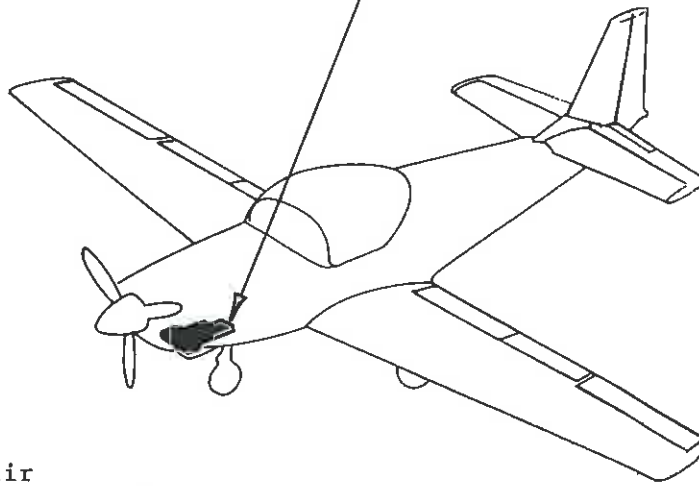
Fig 1

An incident has occurred where spring attachment bracket at the rear of the air injector intake box has fractured. This is possibly due to the bracket being struck by the cowling during fitting. See Fig.1.

GRP Injector Air Intake Box Assy  
Ref

1. Inspect bracket at position indicated on Fig. 1.
2. If a crack is detected fit M596.
3. If a crack is not detected inspect every 25 hours until Mod M596 incorporated.
